Service Bulletin

SUBJECT: Service Update for Inventory and Customer Vehicles
Software Enhancement Update
Expires with Base Warranty

MODELS: 2013 Chevrolet Sonic, Spark, Trax
Equipped with MyLink Radio (UF7)

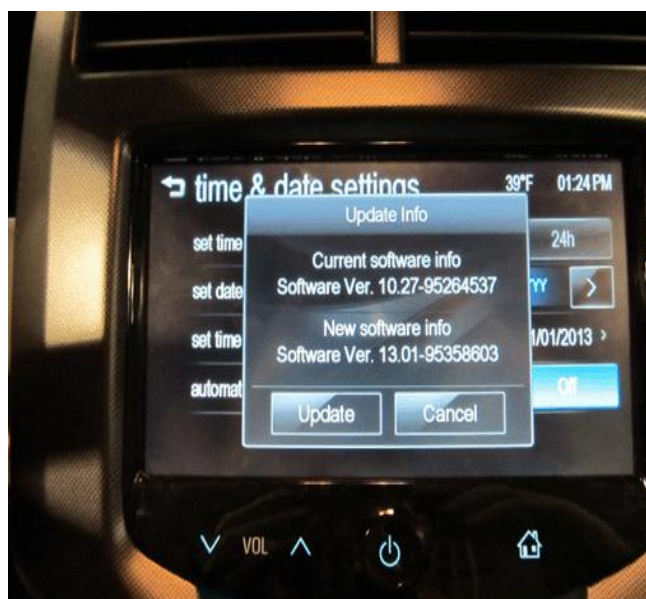
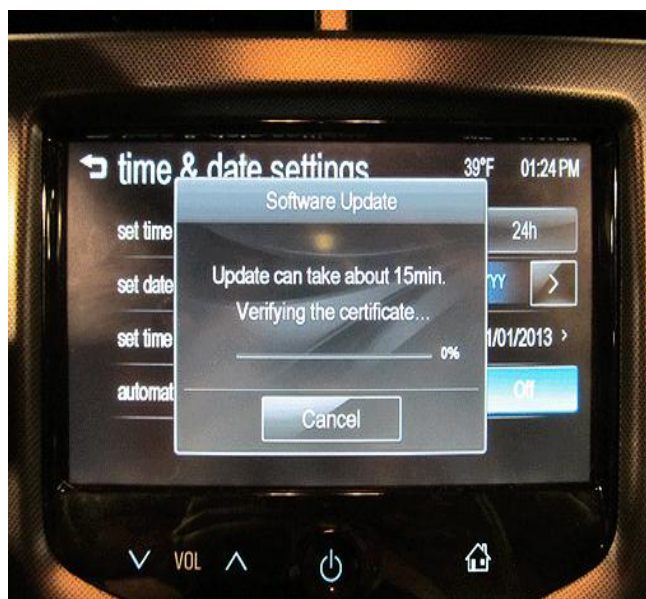
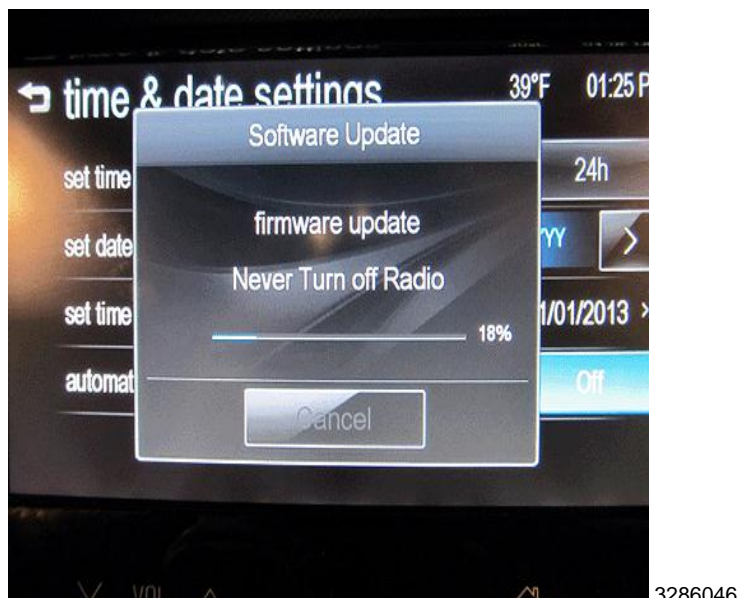
Note: If you still see the message “The following update file is Invalid SMD file,” the date has not been changed correctly on the radio.

15. When the update info screen comes on, select UPDATE.
