Service Bulletin

SUBJECT: Service Update for Inventory and Customer Vehicles
Software Enhancement Update
Expires with Base Warranty

MODELS: 2013 Chevrolet Sonic, Spark, Trax
Equipped with MyLink Radio (UF7)

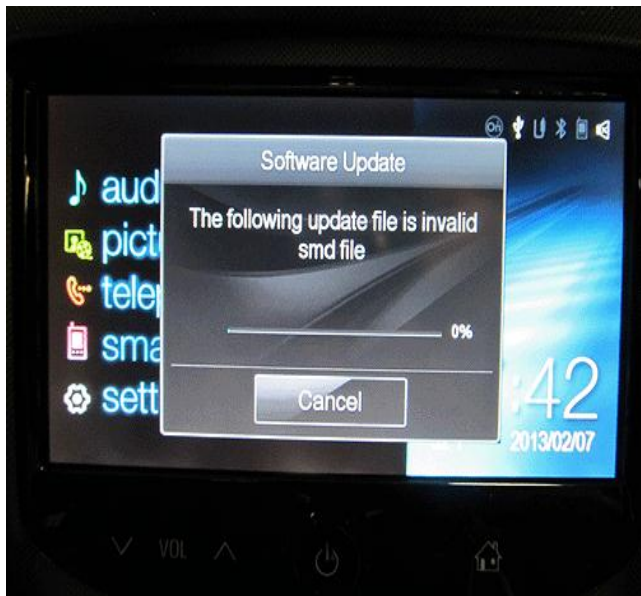
3286662

8. If you see the message as shown above "The following update file is Invalid SMD file," continue to the next step. Otherwise, skip to Step 14.

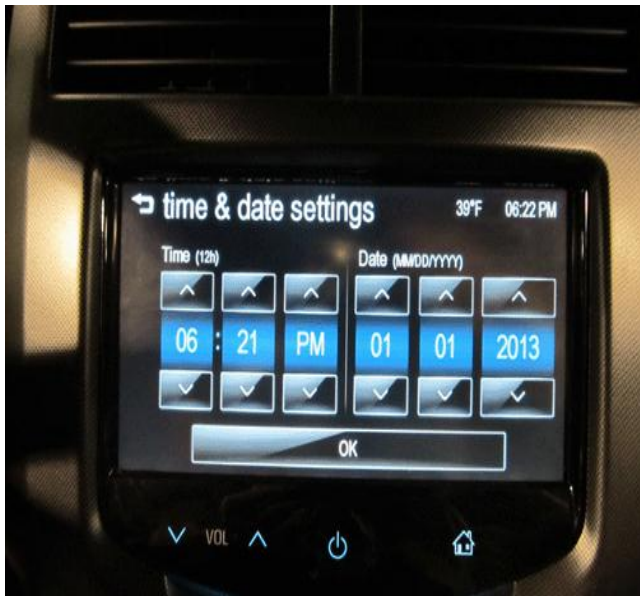
3286032

Note: If you still see the message “The following update file is Invalid SMD file,” the date has not been changed correctly on the radio.

11. On the radio, go into settings and adjust the time 1 hour and change the date to 1/01/2013.
12. Return to the home screen and verify the date change before continuing.
13. If the date did not change, key-cycling the car may be necessary.
14. Insert the USB drive into the radio USB port in the vehicle.
