PRODUCT SAFETY RECALL

SUBJECT: Loss of Battery Charge – Inspect Generator Control Module

MODELS: 2012-2013 Buick LaCrosse, Regal
2013 Chevrolet Malibu Eco
Equipped with eAssist

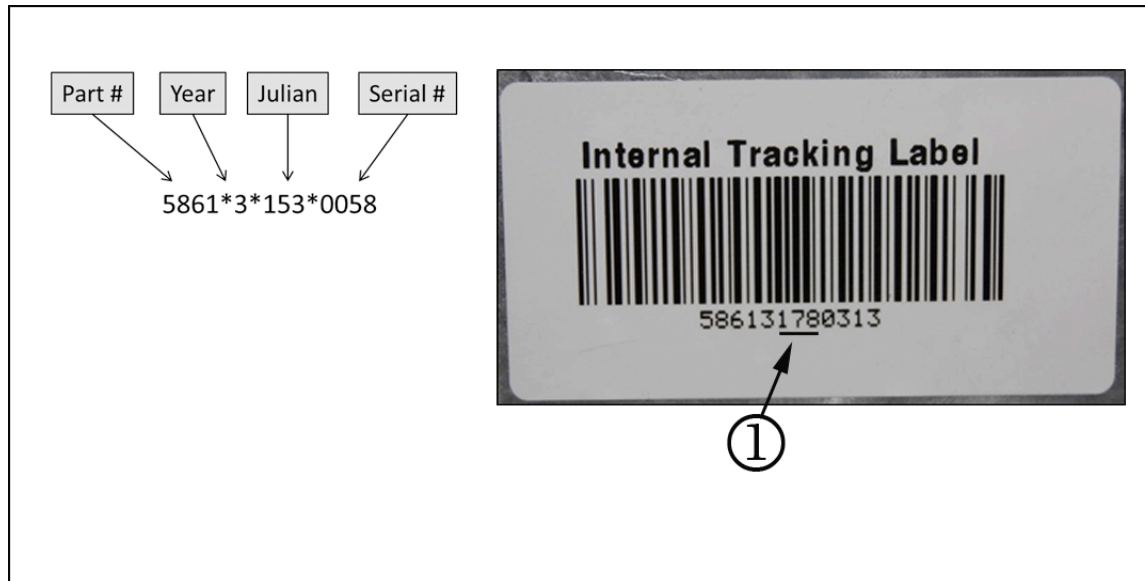
Part Inspection Procedure

Note: Do NOT install GCMs with a Julian date of 171 through 199. Return those modules according to Special Return Bulletin #G_0000171850.

3. Locate the barcode label on the new GCM.
4. Determine the Julian date (1) as shown above.
 - If the Julian date (1) is 171 through 199, do NOT install the module. Obtain another module and perform the inspection again.

- If the Julian date (1) is NOT 171 through 199, the module can be installed in the vehicle.
1. Install GDS2 to vehicle. Start engine and confirm the vehicle has enough fuel for the drive cycle and 2 hour idle test. A quarter-tank of fuel is required to complete the test. Add fuel as required.
