PRODUCT SAFETY RECALL

SUBJECT: Loss of Battery Charge – Inspect Generator Control Module

**MODELS: 2012-2013 Buick LaCrosse, Regal
2013 Chevrolet Malibu Eco
Equipped with eAssist**

GM Recall #13136

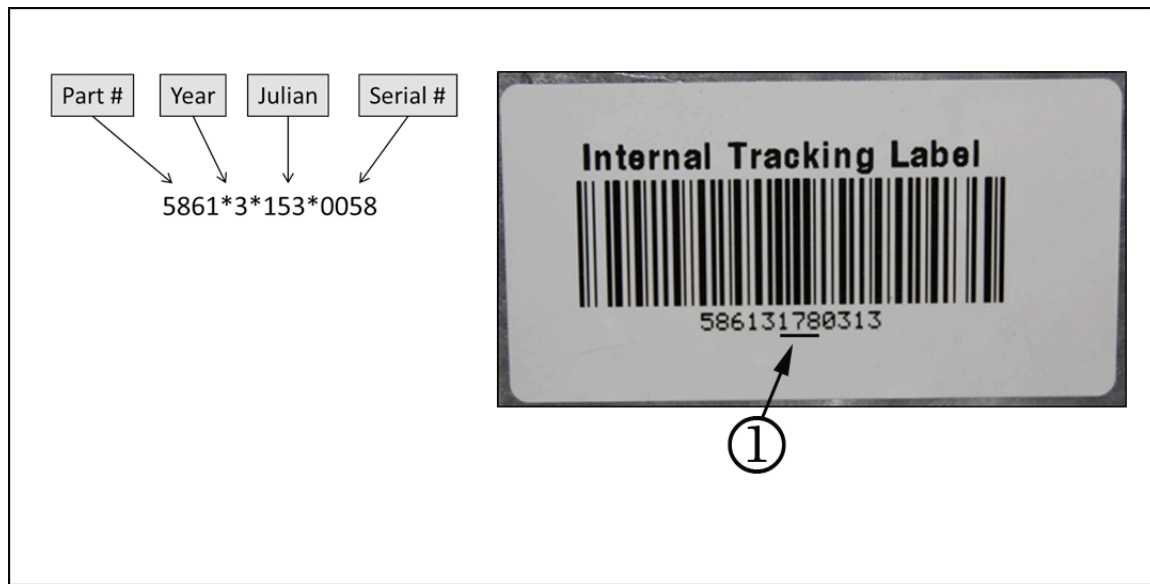
3600552

Generator Control Modules (GCM) with part number 24269448 or 24266403 require an inspection prior to installation in a vehicle. GCMs with part number 24267940 or 24267941 do NOT require inspection prior to installation in a vehicle.

Do NOT provide technicians with GCMs (p/n 24269448 or 24266403) that have a Julian date of 171 through 199. Determine the Julian date following the steps below. Return modules that fail the inspection according to Special Return Bulletin #G_0000171850.

1. Locate the barcode label on the new GCM.

2. Determine the Julian date (1) as shown above.
 - If the Julian date (1) is 171 through 199, do NOT install the module. Obtain another module and perform the inspection again.
 - If the Julian date (1) is NOT 171 through 199, provide to the technician for installation in the vehicle.
