Recall Bulletin

PRODUCT SAFETY RECALL

SUBJECT: Compressed Natural Gas (CNG) Fuel Tank Shut-Off Solenoid Connector

MODELS: 2011-2013 Chevrolet Express
2011-2013 GMC Savana
Equipped with CNG Fuel System

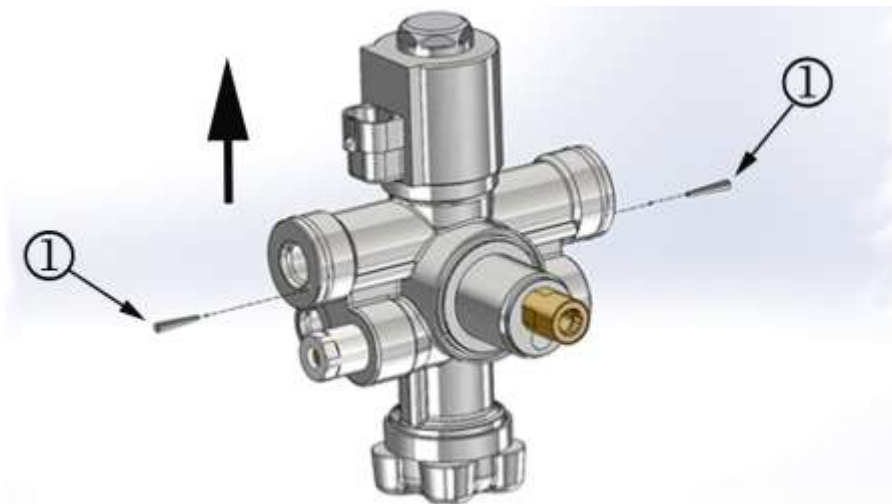
3530550

Connector must point upward.

15. Install two CNG cylinder tank valve plugs (1). Refer to the illustration. This step can be skipped for 2013 model year vehicles, which have plugs already installed.

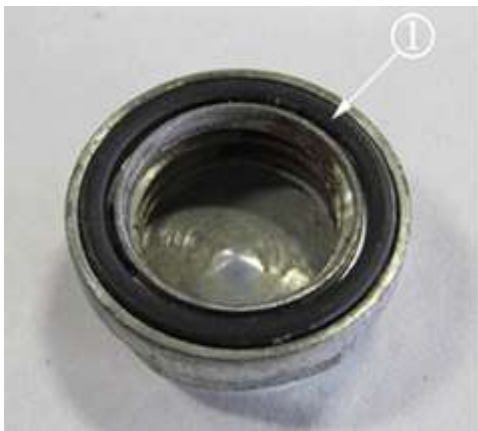
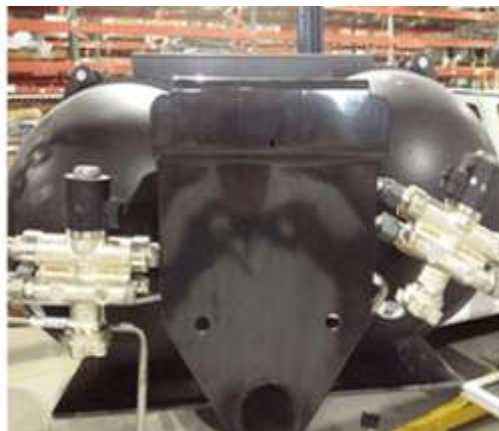
3530545

Note: Both HPL solenoid connectors should face each other after installation.
