Service Bulletin

SERVICE UPDATE

**SUBJECT: Service Update for Inventory and Customer Vehicles
Incorrect Rear Seat Head Restraints Installed
Expires with Base Warranty**

**MODELS: 2014 Chevrolet Impala
Equipped with Rear Seat Folding Head Restraints (AYR)**

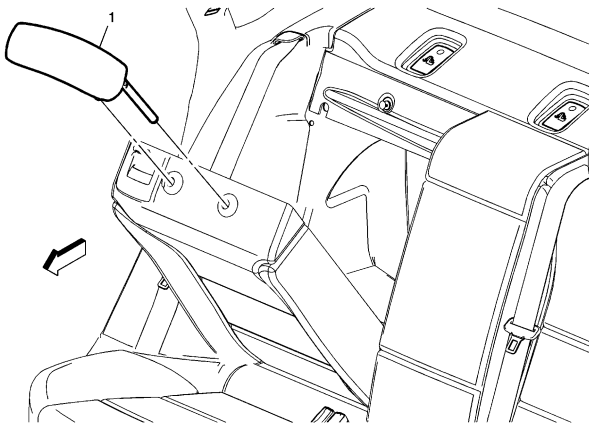
2912351

This bulletin provides a service procedure to install rear seat folding head restraints on **certain** 2014 model year Chevrolet Impala vehicles that were ordered with rear seat folding head restraints (AYR). The rear seats in these vehicles were built with 2-way head restraints rather than the folding head restraints.

Note: Remove and replace both rear seat head restraints.

1. Lower the seat back forward to gain space between the rear seat head restraint and the roof.
2. Depress the large button on the rear seat head restraint guide and raise the rear seat head restraint to the full up position.
3. Insert a small diameter tool into the hole on the inboard side of both rear seat head restraint guides and pull upward to remove the rear seat head restraint.
4. Install two new rear seat head restraints.
