Recall Bulletin

PRODUCT SAFETY RECALL

SUBJECT: Loss of Battery Charge – Replace Generator Control Module

MODELS: 2012-2013 Buick LaCrosse, Regal
2013 Chevrolet Malibu Eco
Equipped with eAssist

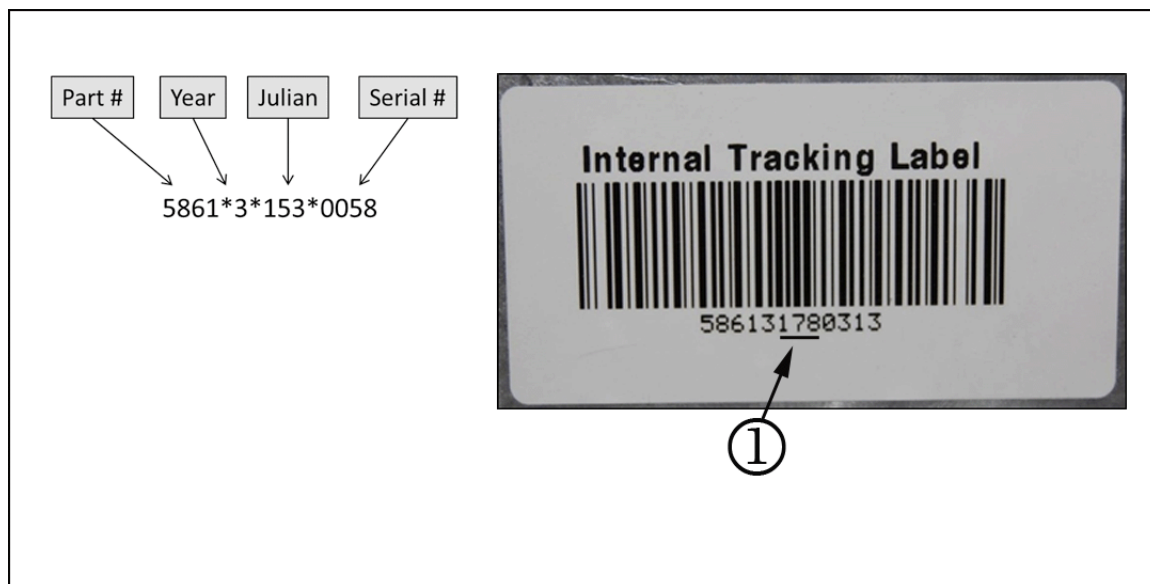
3600552

Do NOT provide technicians with GCMs (p/n 24269448 or 24266403) that have a Julian date of 171 through 199. Determine the Julian date following the steps below. Return modules that fail the inspection according to Special Return Bulletin #G_0000171850.

- 2. Determine the Julian date (1) as shown above.
 - If the Julian date (1) is 171 through 199, proceed to step 3.
 - If the Julian date (1) is NOT 171 through 199, provide the GCM to the technician for installation in the vehicle.

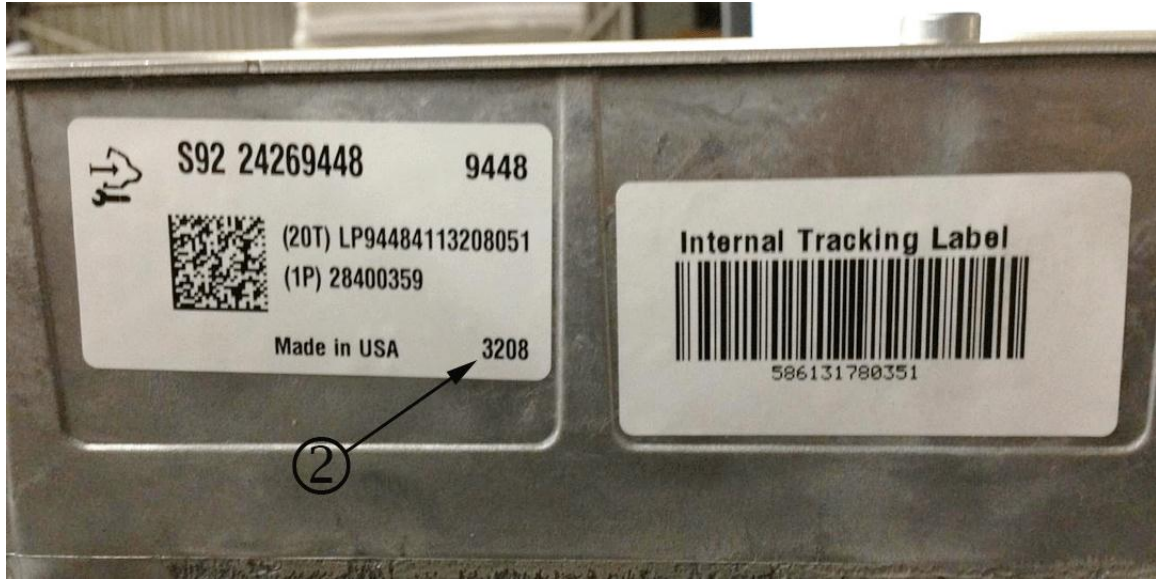
- 3. Locate the Flash label on the GCM.
 - If the number on the lower right-hand side of the label (2) is 3203 or lower, do NOT use the GCM. Obtain another module and perform the inspection again.
 - If the number on the lower right-hand side of the label (2) is 3204 or higher, provide the GCM to the technician for installation in the vehicle.

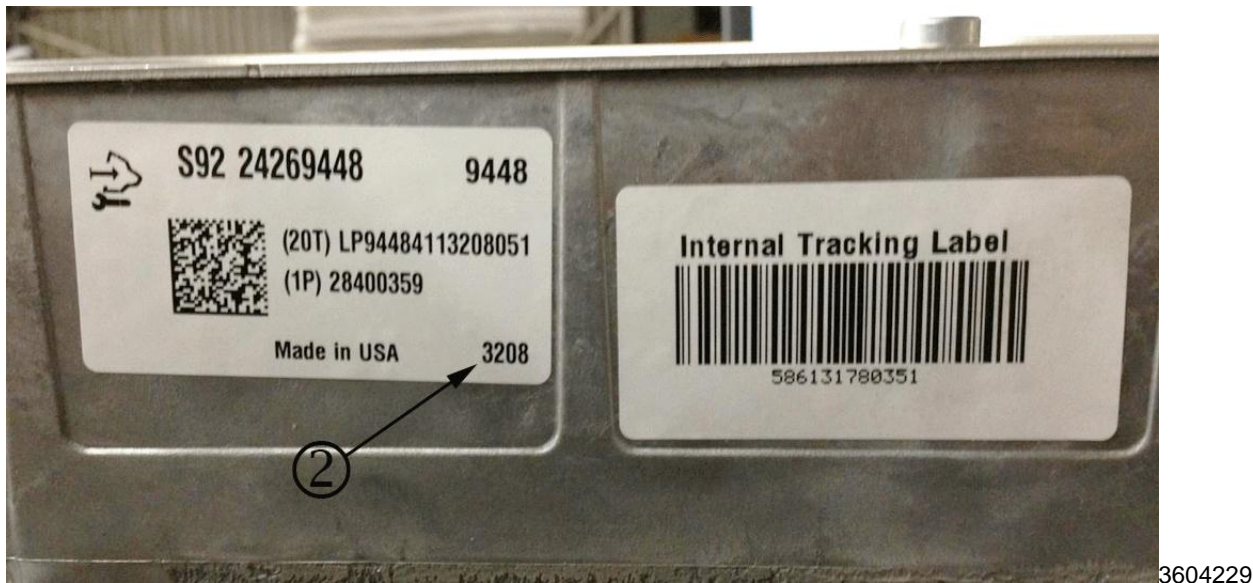
3. Locate the Flash label on the GCM.

- If the number on the lower right-hand side of the label (2) is 3203 or lower, do NOT use the GCM. Obtain another module and perform the inspection again.
- If the number on the lower right-hand side of the label (2) is 3204 or higher, install the GCM in the vehicle.
