Service Bulletin

**SUBJECT: Service Update for Inventory and Customer Vehicles
Possible Windshield Water Leak
Expires with Base Warranty**

MODELS: 2013 Cadillac ATS

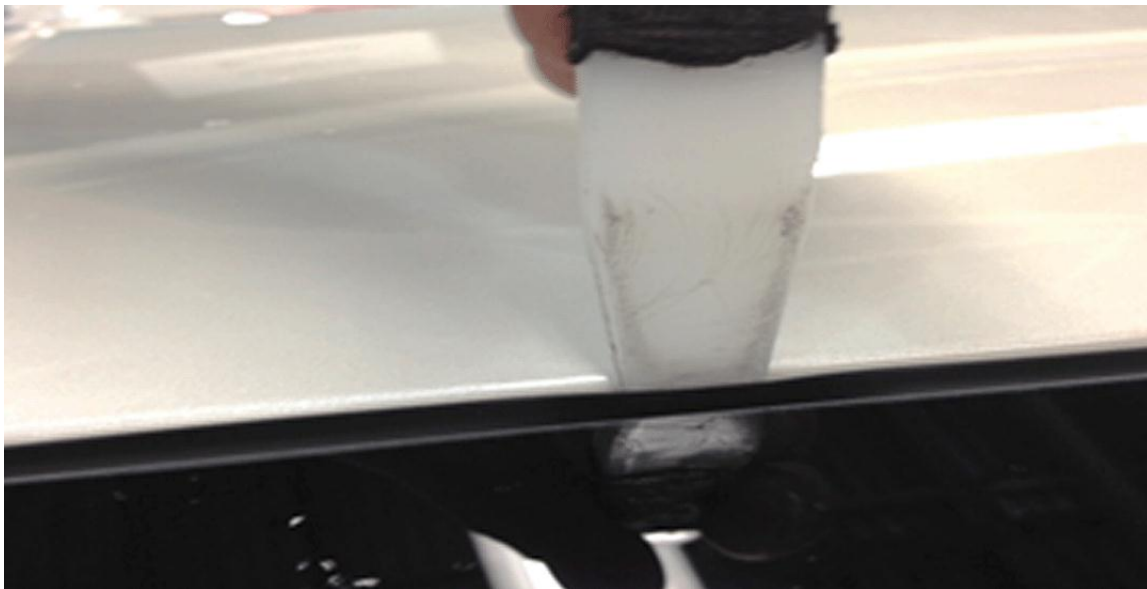
3468441

- 1.1 Using a trim stick start at the passenger side top corner of the windshield lace and gently run under the lace with the trim stick to separate it from windshield.

Note: Flow water into the access opening created by the trim stick in the test area of the windshield for 1-2 minutes.

1.2 Flow water into the access opening created by the trim stick until it flows over windshield.
