Service Bulletin

SUBJECT: Service Update for Inventory and Customer Vehicles
Turbo Vacuum Hose Routing - Inspect
Expires with Base Warranty

MODELS: 2014 Cadillac XTS
Equipped with 3.6L V6 Engine (LF3)

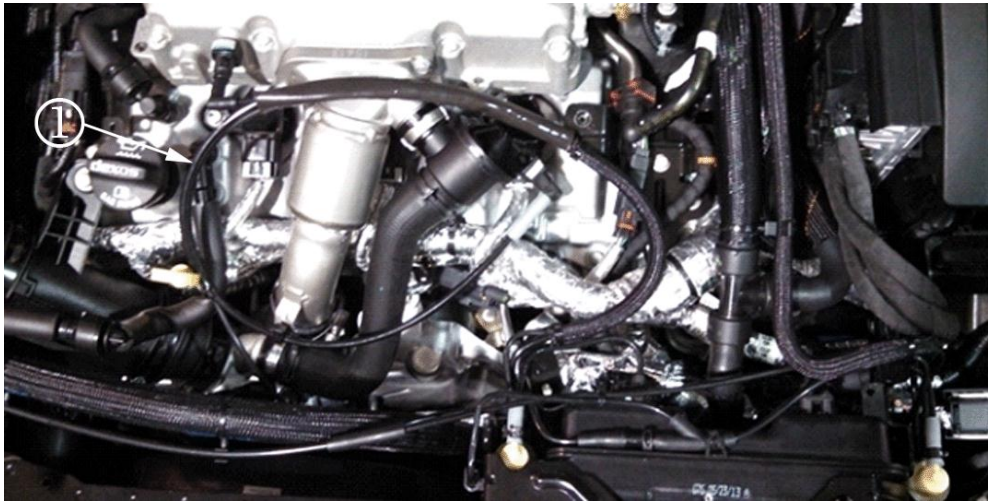
Correct Routing

3. Determine if the turbo charger wastegate actuator vacuum boost tube bundle for the left cylinder bank is properly routed and free from kinks.

- If the turbo charger wastegate actuator vacuum boost tube bundle (1) is routed correctly, no further action is required. Install the intake manifold cover and front compartment front sight shield. Refer to *Intake Manifold Cover Replacement* and *Front Compartment Front Sight Shield Replacement* in SI.
