Service Bulletin

SUBJECT: Service Update for Inventory Vehicles Only
Transmission Snap Ring Misalignment
Expires September 30, 2014

MODELS: 2013 Buick Regal, LaCrosse
2013 Chevrolet Malibu
Equipped with 6T40 Automatic Transmission (MHH)

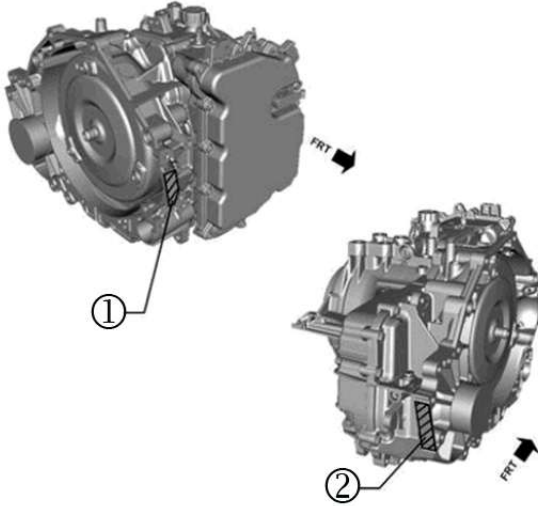
3613040

Note: A VIN derivative is required to be permanently engraved on the new transmission prior to installation. Refer to the illustration above for VIN engraving location points. Select one of the locations to engrave the required characters. VIN derivatives must be formatted as indicated below (# = last eight characters of the VIN).
