# Recall Bulletin

## F/CMVSS NONCOMPLIANCE RECALL

**SUBJECT: Manual Seatback Recliner Lever**

**MODELS: 2014 Chevrolet Silverado  
2014 GMC Sierra  
1500 Series Equipped with Manual Reclining Seatback**

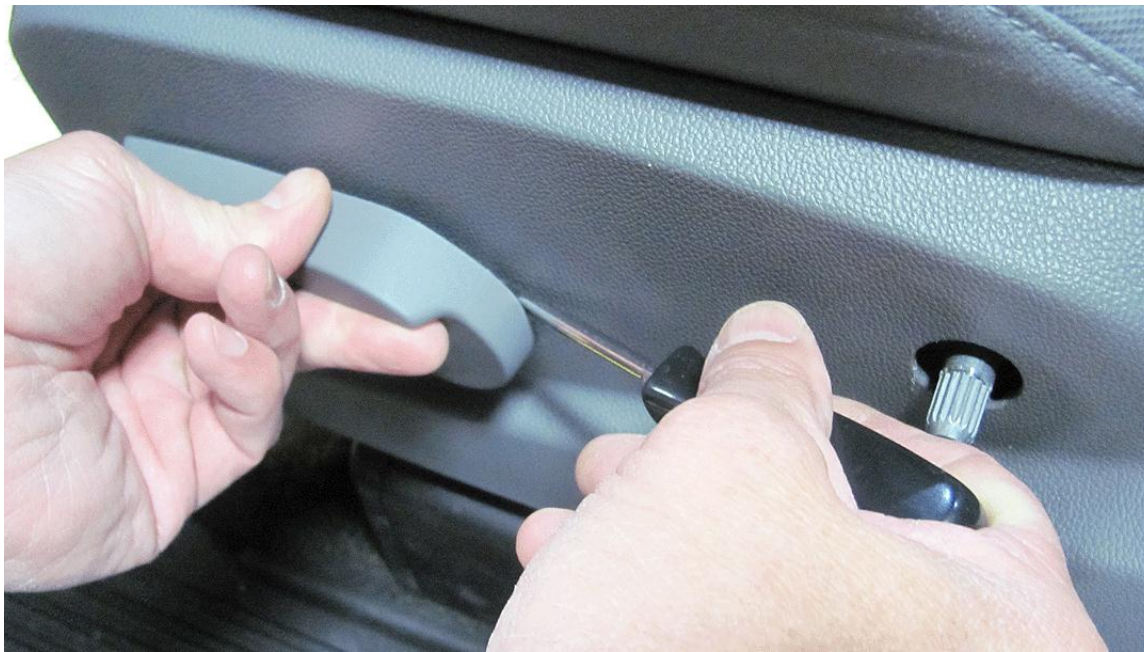
3630332

**Note:** There are two slots (1) on the handle collar. BOTH slots (1) must be broken to remove the handle. Refer to the photograph. Portion 'A' of the photograph shows the unbroken slots (1). Portion 'B' of the photograph shows the two broken slots (2).

**Caution:** Do NOT twist the screw driver in the slot to avoid damaging lumbar spline and locating tab. Carefully pry inward with the screw driver until the slot breaks to avoid damaging the front seat cushion outer finish cover.

2. Using a flat-blade screw driver, pry inward toward the front seat cushion outer finish cover to snap the slot on the handle collar.
3. After completing the *Recliner Cable Adjustment* procedure and installing the front seat cushion outer finish cover, install a new manual lumbar handle.
