Recall Bulletin

PRODUCT SAFETY RECALL

SUBJECT: Power Seat Wiring Harness Chafing

MODELS: 2013 Chevrolet Malibu
Equipped with 8-Way Power Front Seat Feature (AG1/AG2) and without
Memory Seat Feature (A45)

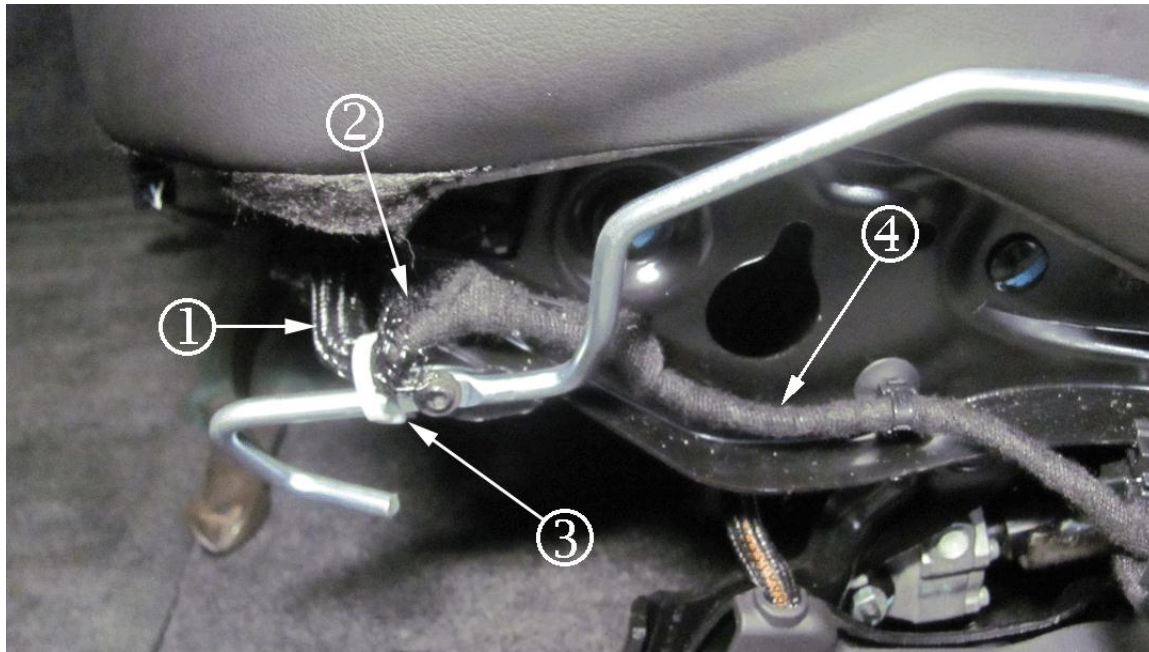
3642534

3. Examine the seat wiring harness (4) to determine if it has a harness protector (1), tie strap (3) and Velcro tape patch (2) on the front edge of the seat frame.
 - If the harness protector, tie strap and Velcro tape patch are present, no further action is required. Install the driver and/or passenger seat outer recliner finish cover. Refer to *Driver or Passenger Seat Outer Recliner Finish Cover Replacement* in SI.
 - If the harness protector, tie strap and Velcro tape patch are NOT present, proceed to step 4.
4. Inspect the seat wire harness wrapping for damage. If the wiring insulation becomes worn or cut through to the conductor a short to the grounded seat frame may occur. Repair wire harness, if necessary. Refer to the appropriate wire repair procedures in SI.
