# Service Bulletin

**SUBJECT:** Service Update for Inventory and Customer Vehicles  
Front Bumper Fascia Air Deflector Replacement  
Expires with Base Warranty

**MODELS:** 2013 Chevrolet Malibu  
Equipped with Active Grille Shutters (VRI) and Located in Alabama,  
Arkansas, Arizona, Florida, Georgia, Louisiana, Mississippi, New Mexico,  
Oklahoma, South Carolina, Texas, and Israel

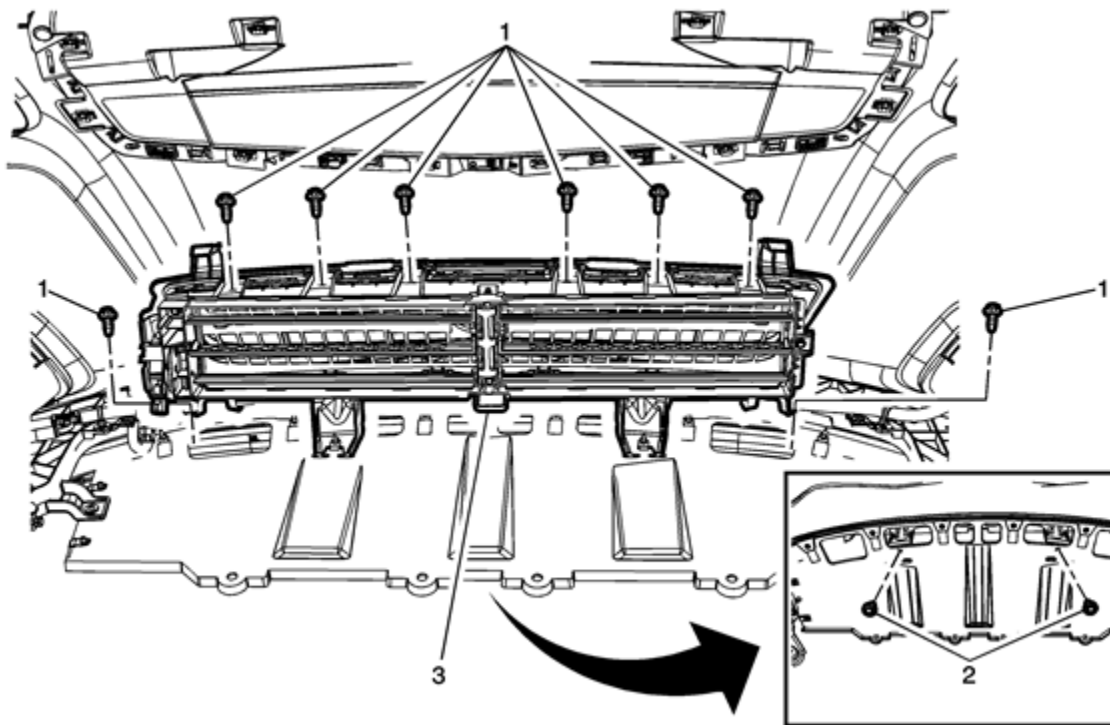
2717668

This bulletin provides a service procedure to replace the front bumper fascia air deflector on **certain** 2013 model year Chevrolet Malibu vehicles that are equipped with active grille shutters (VRI) and located in the following hot weather areas: Alabama, Arkansas, Arizona, Florida, Georgia, Louisiana, Mississippi, New Mexico, Oklahoma, South Carolina, Texas, and Israel. The front grille shutter actuator on these vehicles may exceed the actuator's angular tolerance range. This could cause the illumination of the Service Engine Soon lamp; however it does not affect the operation of the grille shutter assembly and it will continue to operate properly.

1. Remove the front bumper fascia air deflector from the vehicle. Refer to *Front Bumper Fascia Air Deflector* in SI.
2. Install a new front bumper fascia air deflector. Refer to *Front Bumper Fascia Air Deflector* in SI.
