TECHNICAL BULLETIN  
LTB00528NAS1  
31 MAY 2013

**SECTION: 501-08**

Front Door Side Vent Contacts Fender

Range Rover (LG)

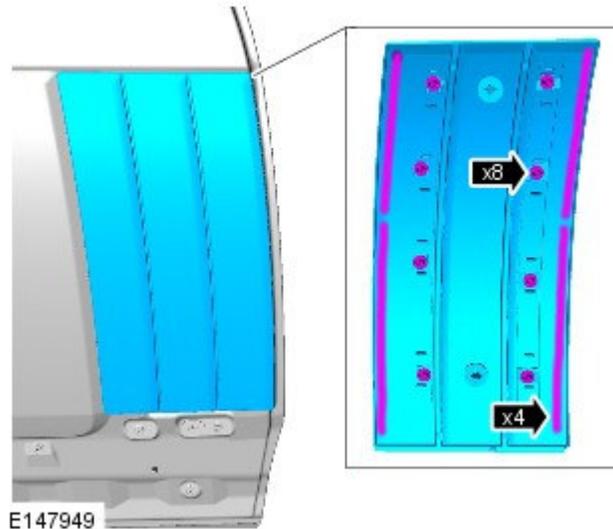
Check that the door side vent is correctly installed to the vehicle.

- Make sure that the side vent is correctly secured by the eight (8) clips and adhered at the front and rear edges.
- If the side vent is not correctly installed, remove and correctly install the side vent with new clips and / or adhesive tape as required.
- Check the gap and flush of the door side vent to the fender.
  - If the gap is less than 3 mm and the door side vent is outboard of the fender by 0.5mm or above, continue to step 2.

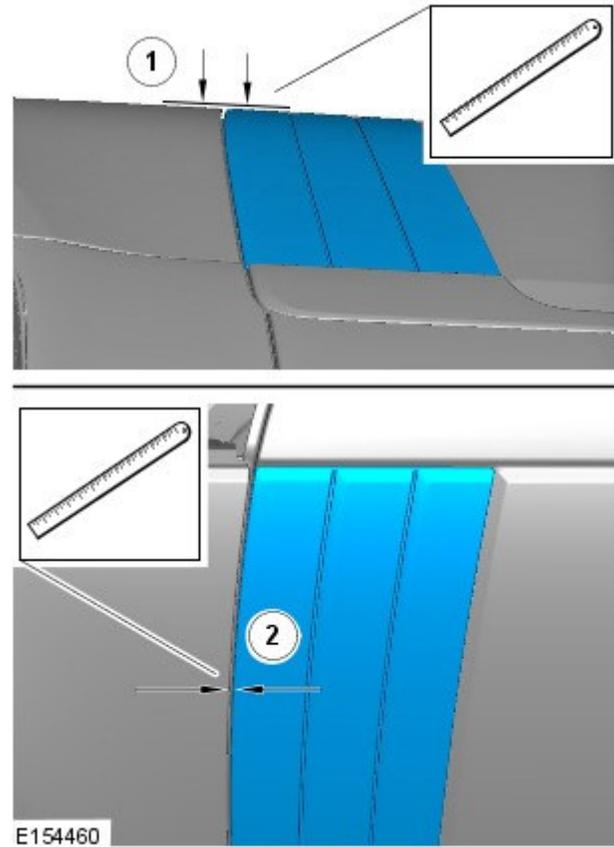
2. **NOTE: The door side vent should protrude a maximum of 0.5mm above the fender.**

Carry out a tolerance check between the front door and the front fender.

- Check that the flushness of the side vent to the front fender is  $-0.5\text{mm} \pm 1\text{mm}$ .
- Check that the gap between the fender and the door is  $4\text{mm} \pm 1\text{mm}$ .
- If the measurements are outside of the tolerances above, adjust the door to achieve the correct tolerances.
