TECHNICAL BULLETIN
LTB00537NAS1
01 JUL 2013

SECTION: 501-10

Front Massage Seat Poor / No Operation

Range Rover (LG)

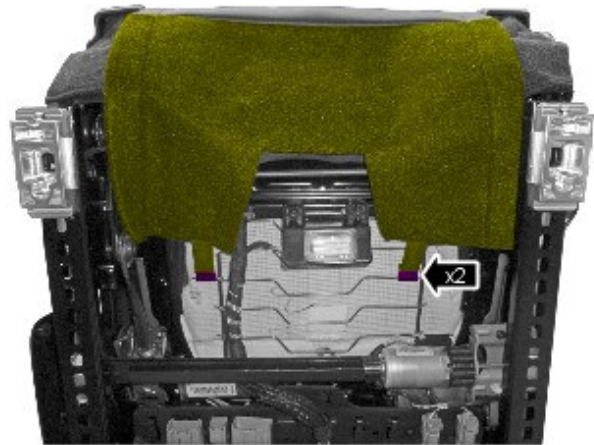
E143833

On the affected seat, release the two (2) elastic straps.

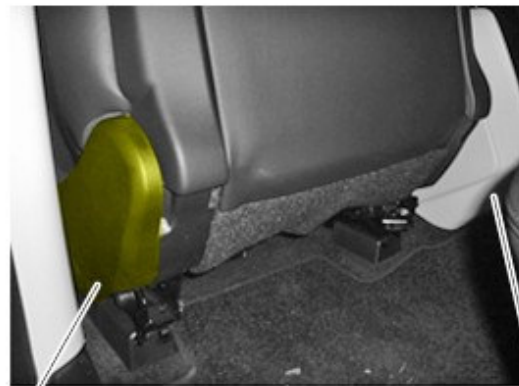
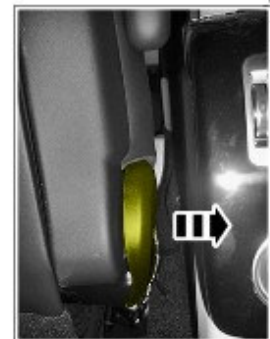
E152342

Carefully reposition the two (2) trim panels to allow access to the seat spindles.

- Release the four (4) clips on the outer trim panel.

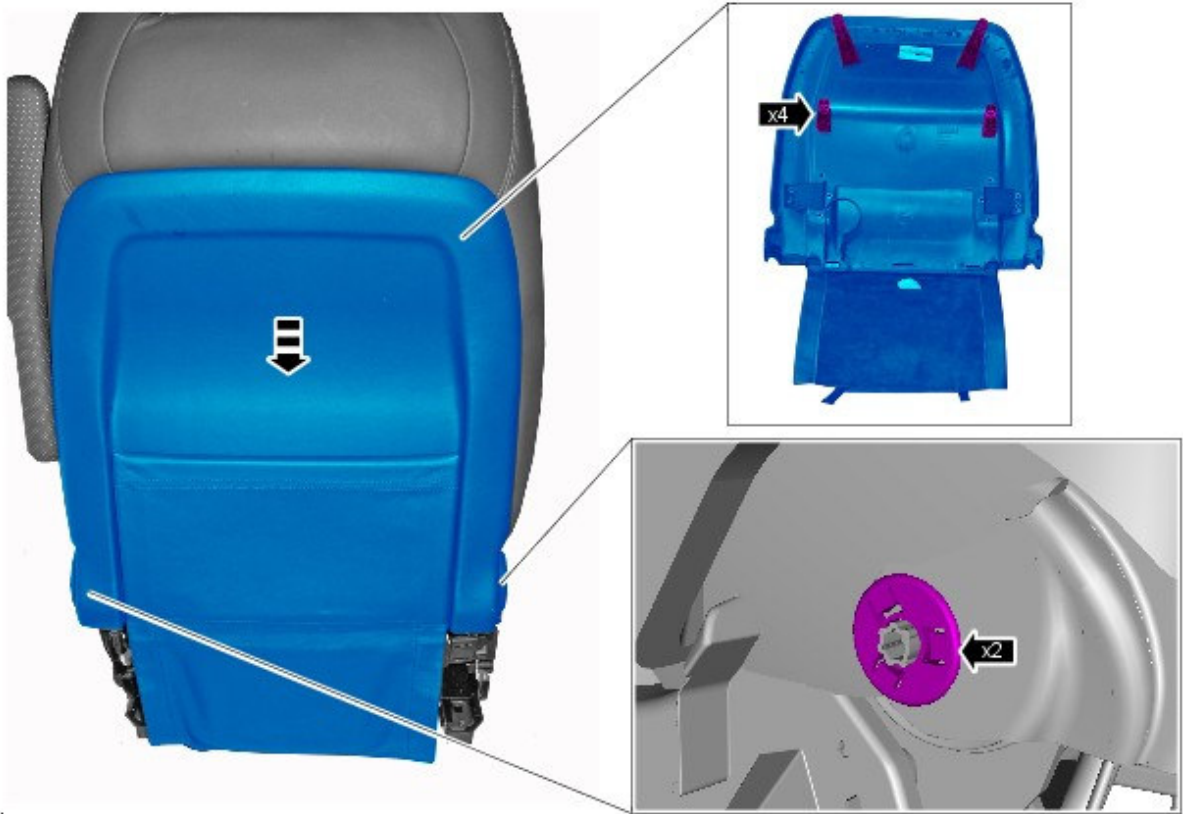
E143831

3. Remove the seat back.

- Carefully release the seat back over the two (2) spindles.
- Slide the seat back downwards.

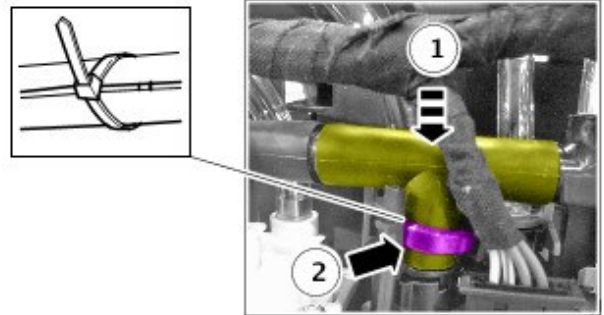
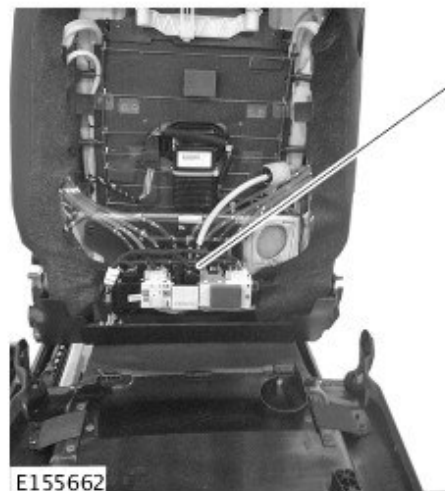
E155662

Cause: This may be caused by the massage pipe from seat control assembly coming adrift.

**CAUTION: Make sure all the air pipes are correctly installed before installing the seat back.**

Secure the air pipe to the solenoid in the position shown.

- Push the pipe securely into place.
- Secure pipe in place with tie strap.

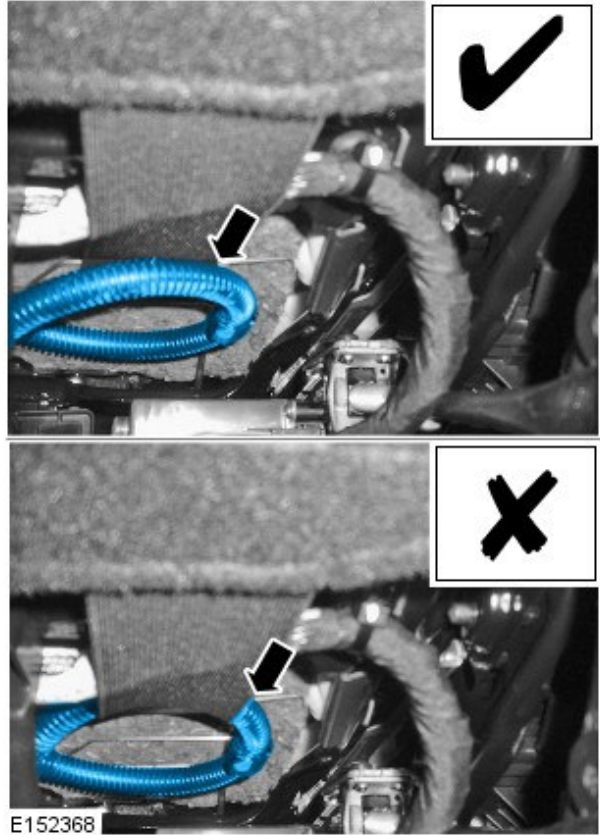
**CAUTION: Make sure that the Occupancy Classification System (OCS) harness (where fitted) is routed below the elastic strap as shown.**

To install, reverse steps 1-4.
