TECHNICAL BULLETIN
LTB00602NAS1
19 NOV 2013

SECTION: 501-05

Sun Visor Vanity Mirror Sliding Cover Opens/Closes While Driving

Range Rover Sport (LW)

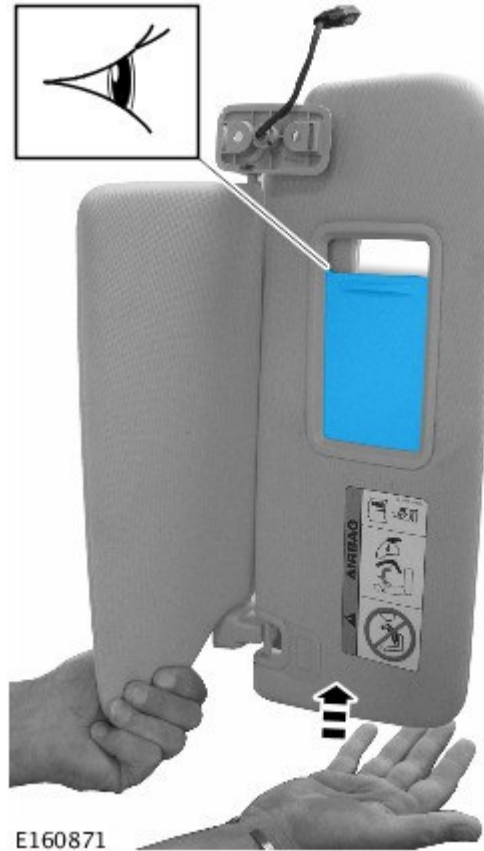
1. Remove the affected sun visor (see TOPIx Workshop Manual, Section 501-05).
2. Lightly tap the bottom of the sun visor.
 - If the vanity mirror sliding cover opens and is loose, continue to step 3.

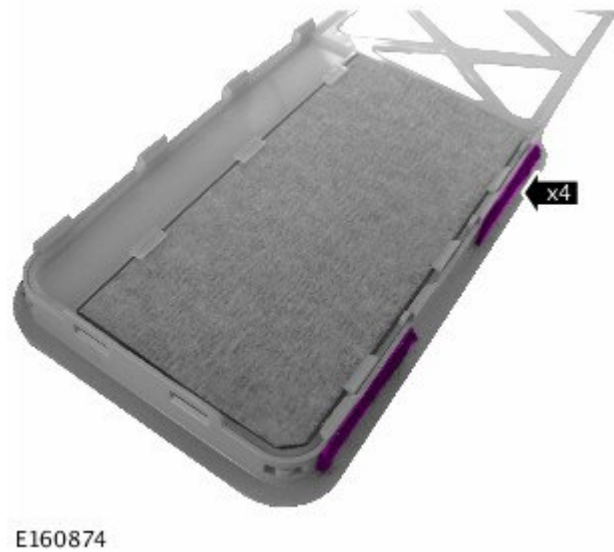
Cause: This may be caused by insufficient retention of the sun visor vanity mirror sliding cover.

5. Apply felt tape (40mm X 8mm X 1mm) from the Squeaks & Rattles Kit to sun visor vanity mirror at the both ends of the top and bottom edges of the vanity mirror bezel as shown.

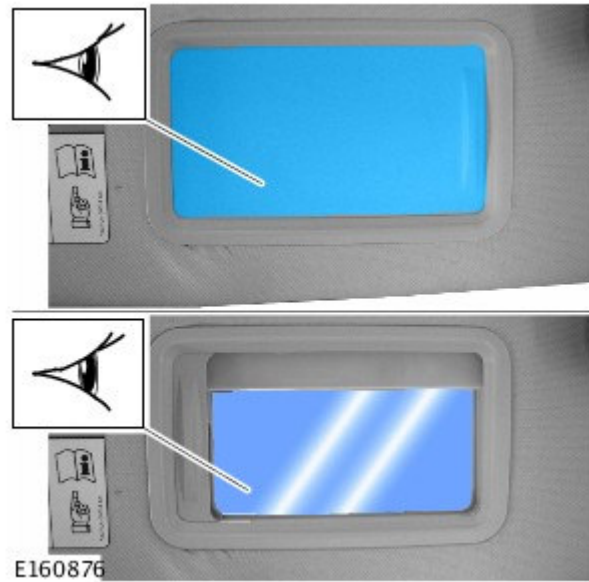
- Make sure there is no dirt or scratch marks on sliding cover face.
- Make sure the mirror is not cracked and close sliding cover.

7. Open and close the vanity mirror sliding cover:

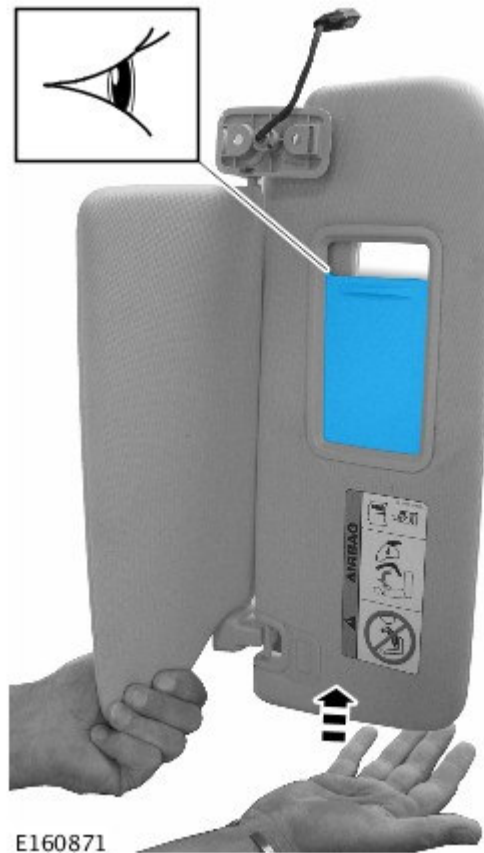
8. Lightly tap the bottom of the sun visor.

- If the vanity mirror sliding cover does not open and is not loose, continue to step 9.
- If the vanity mirror sliding cover opens and is loose, replace the sun visor.
