TECHNICAL BULLETIN  
LTB00605NAS1  
19 NOV 2013

Front Seatback Tilt Lever Inoperative

**Range Rover Evoque (LV)**

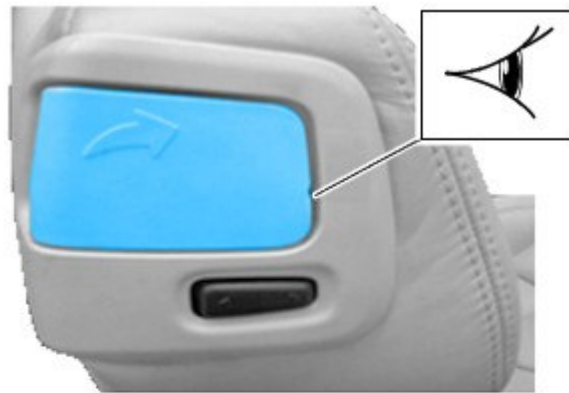
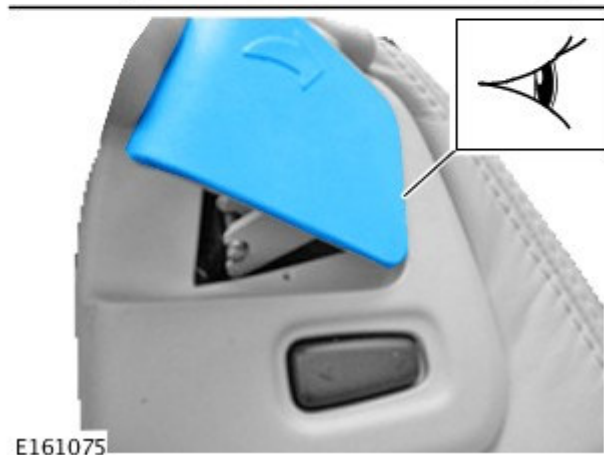
1.

**NOTE: Front right seatback shown; front left seatback similar.**

Lift the front right seatback locking lever and pivot the seatback forwards; make sure that there is no contact between the front edge of the lever and the bezel when the lever is lifted.

- If no contact between the lever and bezel is evident or the seatback does not release, continue to step 2.
- If contact between the lever and bezel is evident, replace the lever. To be performed as a separate claim.

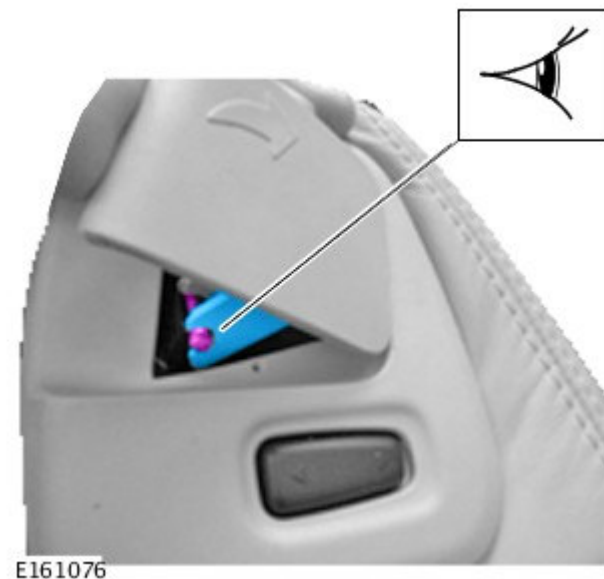
2. Lift the front seatback locking lever and check for cable disconnection:

- Make sure that the silver cable end is in the correct position on the lever.
- If the cable is not properly retained, remove the lever and check for damage.
  - If damage is evident, replace the lever. To be performed as a separate claim.
  - If no damage is evident, re-fit the lever.
