TECHNICAL BULLETIN

LTB00606NAS1
19 NOV 2013

Engine MIL Illuminated with DTC P0505-8F and P2282-00 Stored and Misfire DTC May Be Stored

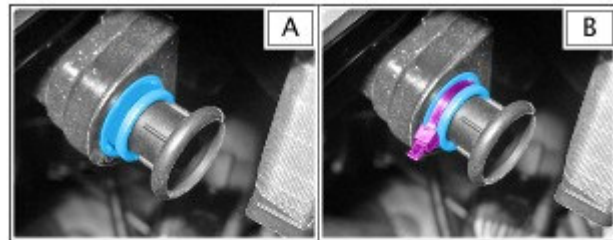
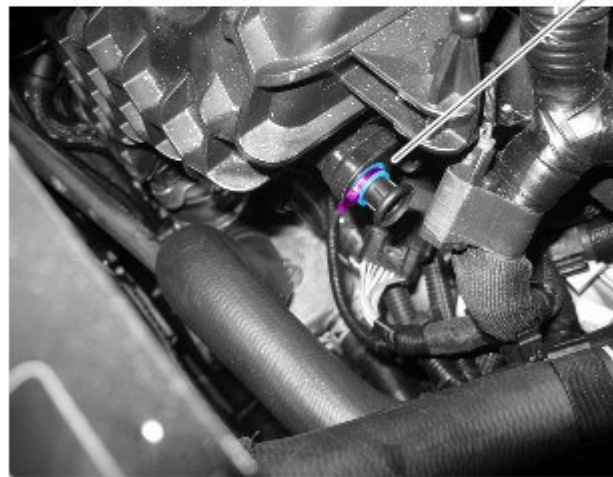
E160401

Cause: This may be caused by the intake manifold vacuum plug having fallen out.

5. **NOTE: Make sure tie strap is seated below the flange.**

Install the nylon tie strap between the retaining ring and the face of the locking ring:

- Pull the tie strap tightly around the retaining ring.
- Cut off any excess tie strap material.
