# TECHNICAL BULLETIN

Q057NAS5

### Service Action: Fuel Pump Module Operation

Freelander (L314) - USA vehicles *only*

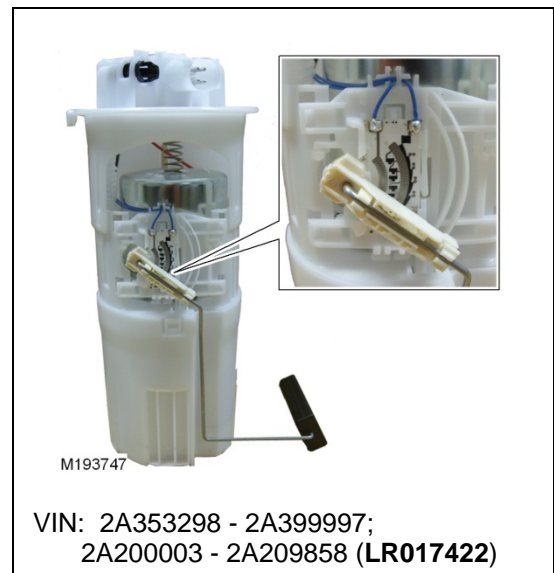
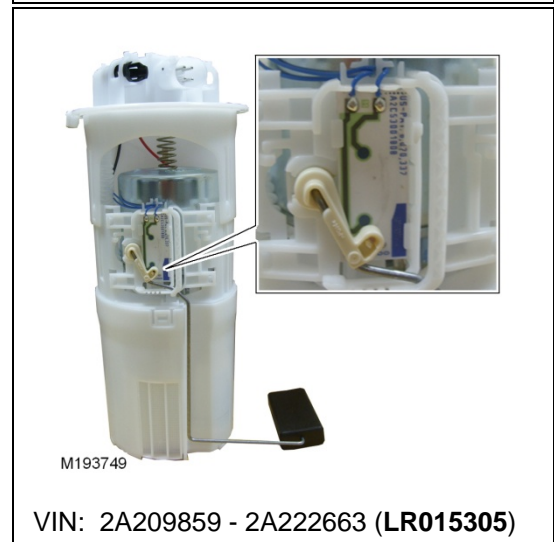
2. Compare existing fuel pump module sender unit to new fuel pump module sender unit, ensuring correct fuel pump module is installed:

#### As-built Spec:

- VIN: 2A353298 - 2A399997; 2A200003 - 2A209858 (LR017422)

- VIN: 2A209859 - 2A222663 (LR015305)

- ⚠ CAUTION: Due to the possibility of past repairs to the fuel pump module / sender unit being performed incorrectly, it is necessary to physically compare the existing fuel pump module to the recommended replacement. Ensure the new fuel pump module matches the existing *prior* to installation. Failure to do so will lead to incorrect fuel gauge operation.**
