TECHNICAL BULLETIN

Q247NAS1

Service Action: Power Tailgate

Range Rover (LG)
Model Year: 2013
VIN: DA100499-DA105029

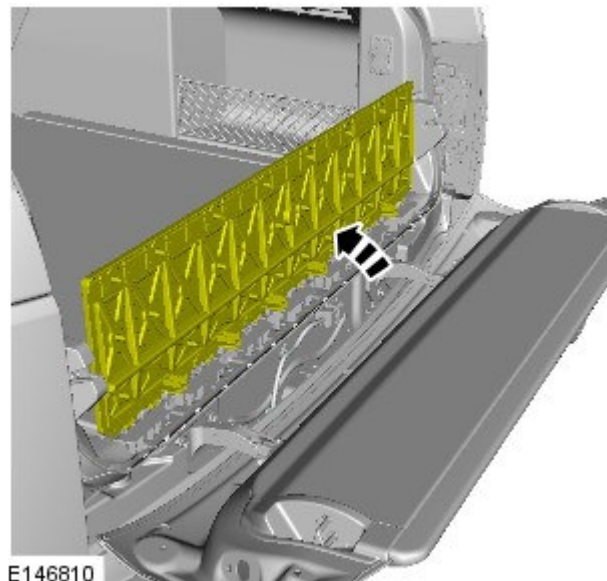
1. Open upper and lower tailgates.

- Raise the lift bridge.

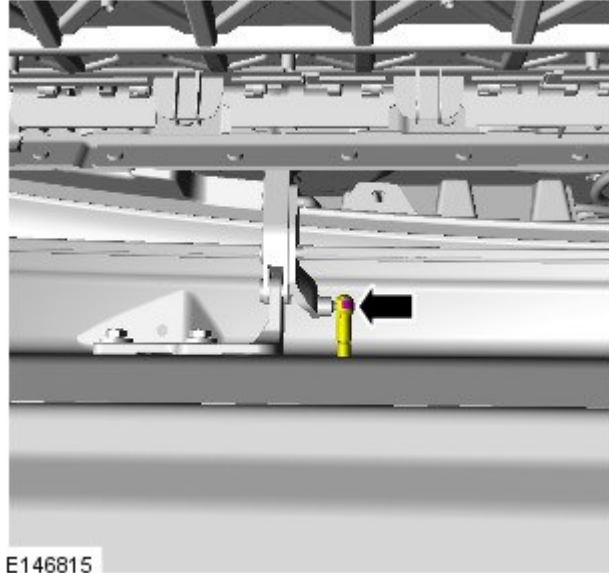
2. Locate lower tailgate push rod and ball spigot attachment.

- Using a suitable tool remove the clip.
- Disconnect the push rod.

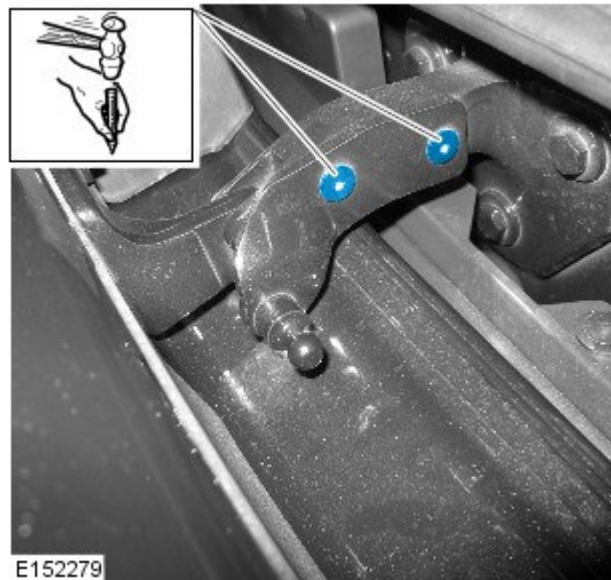
3. Using a suitable tool, center dot the rivet prior to drilling.

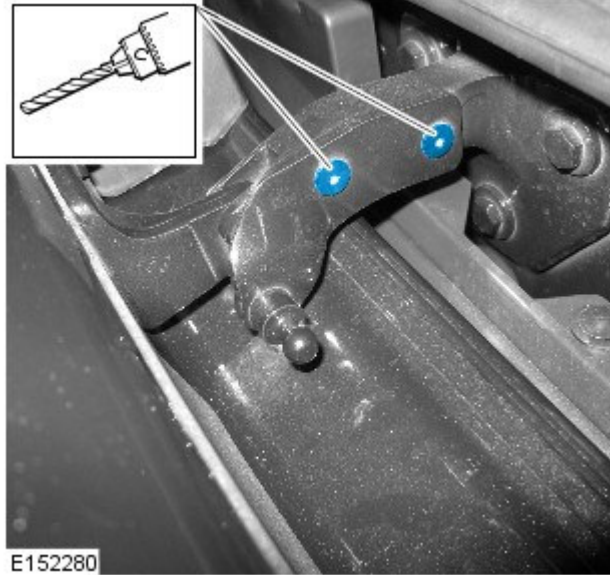
NOTE: Make sure to carry out drilling as per graphic.

Drill the head from the rivet.

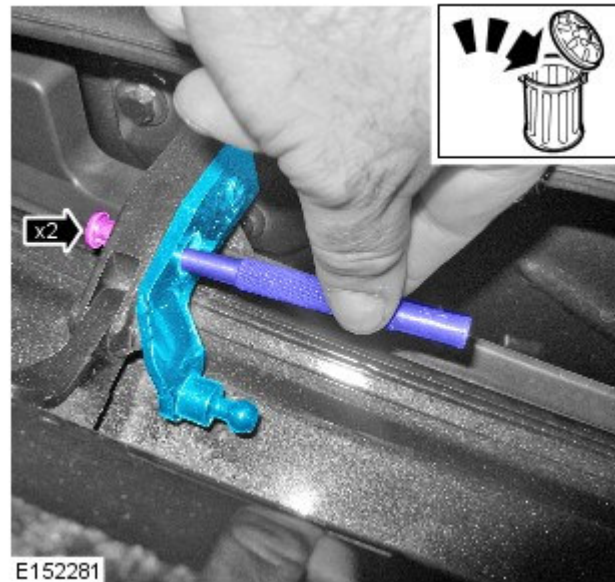
5. Using a suitable tool, remove the remains of the rivet.

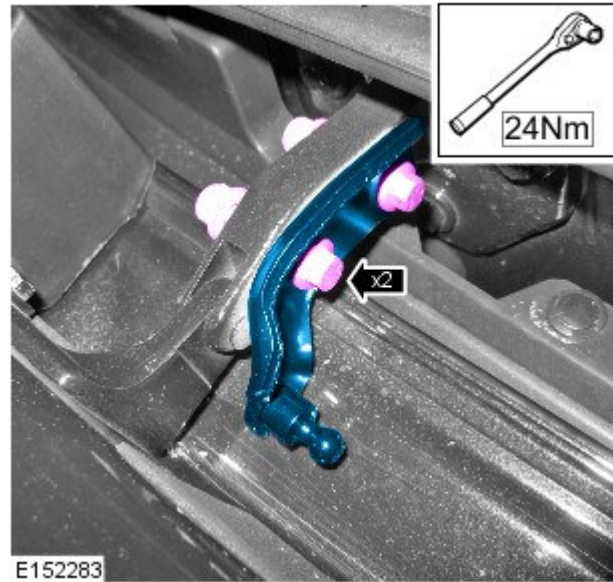
6. Repeat the procedure to the other rivet.
7. Remove all traces of swarf from the drilling process.
8. Install the new ball Spigot Bracket.

- Install the fixing nuts and bolts.
- Torque the fixings to 24Nm.

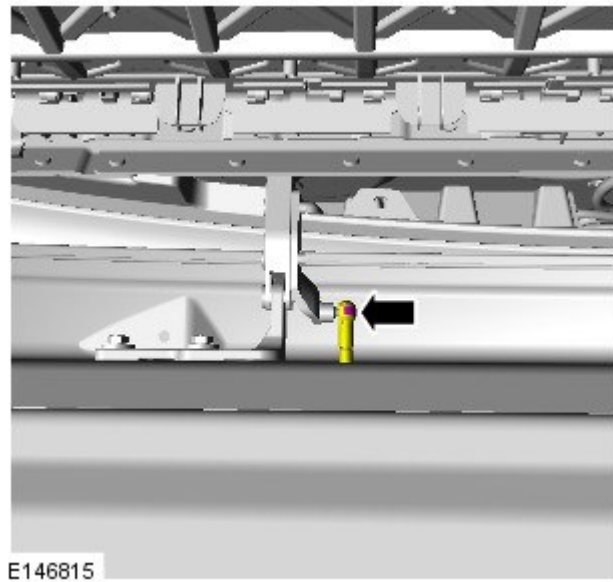
- 9.** Install the push rod to the ball spigot attachment.

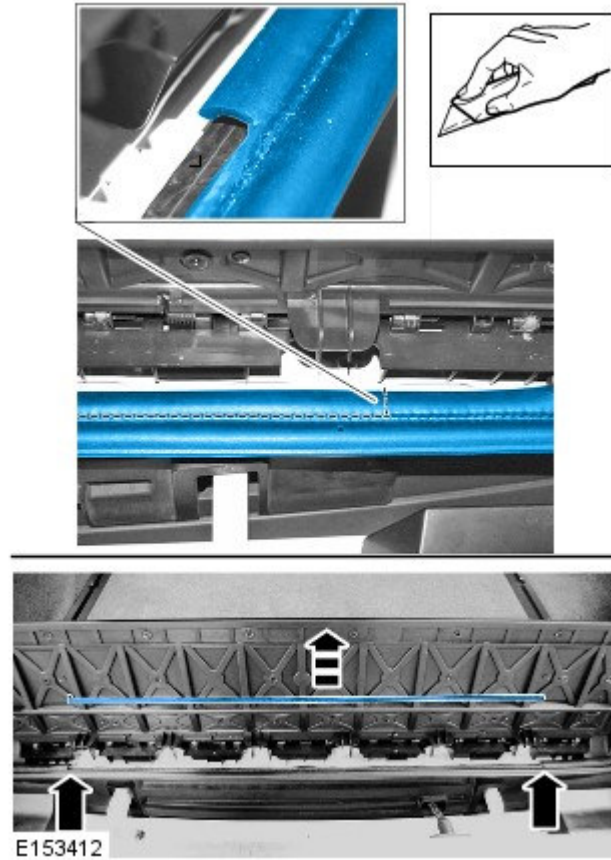
- 10.** Raise the lift bridge.

- Cut and discard aperture seal between the arrows shown.

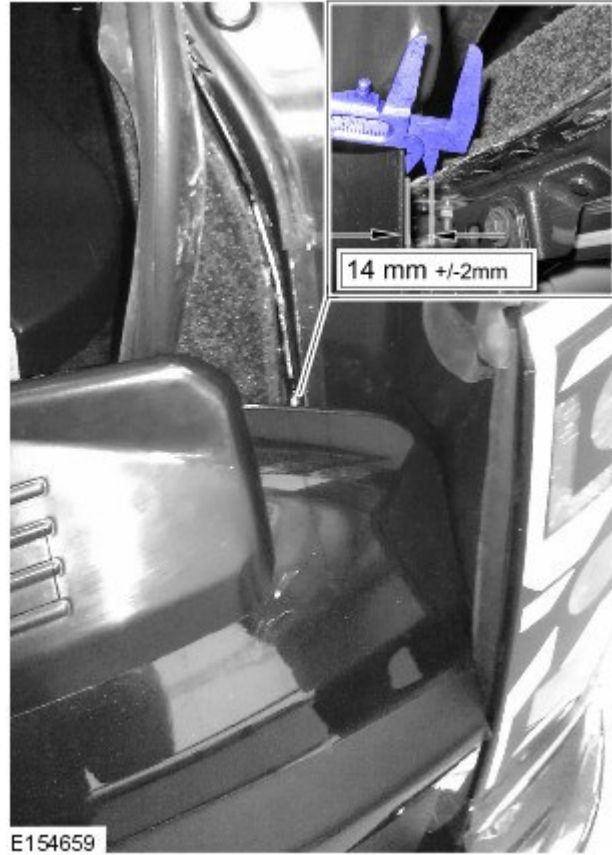
11. Remove the aperture seal as shown.

- Close the lower tailgate
- Measure the clearance as shown.

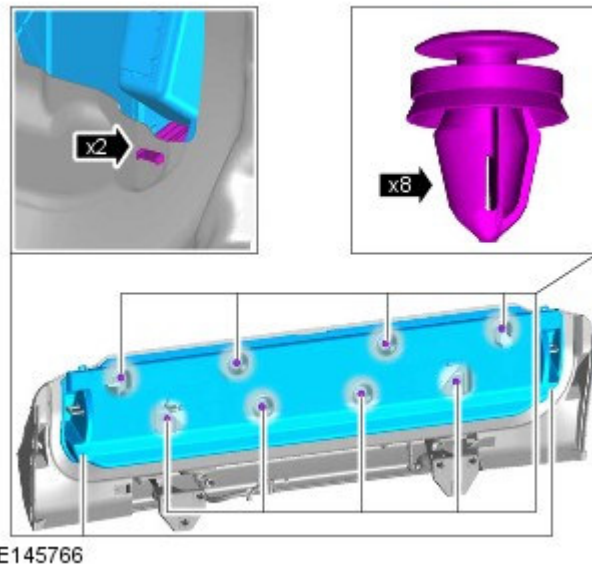
12. If the lower tailgate clearance is outside of the 14mm +/- 2mm, remove lower tailgate trim.

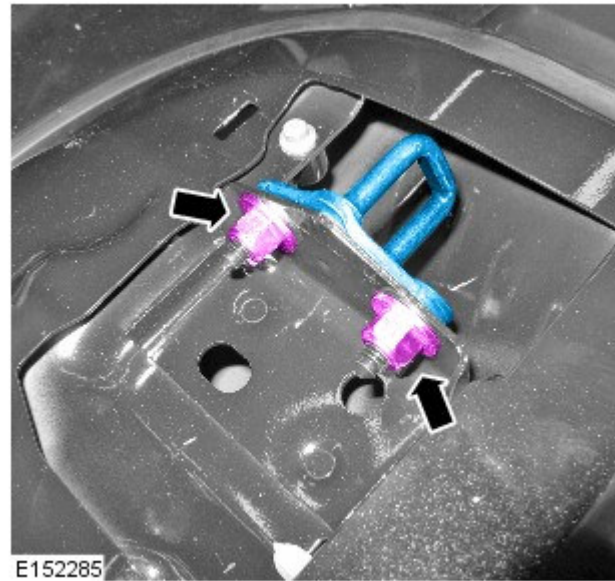
13. Adjust to give the required clearance.

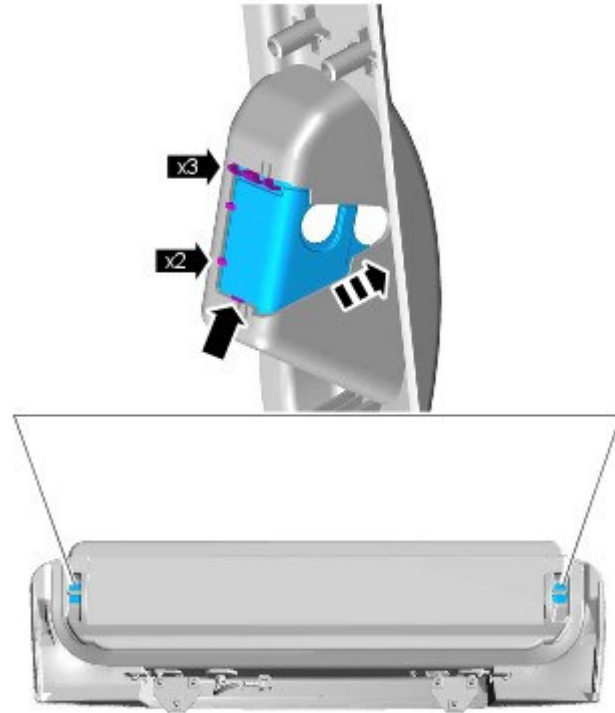
E145770

15. Install the lower tailgate trim.

- Fit trims inserts as shown.

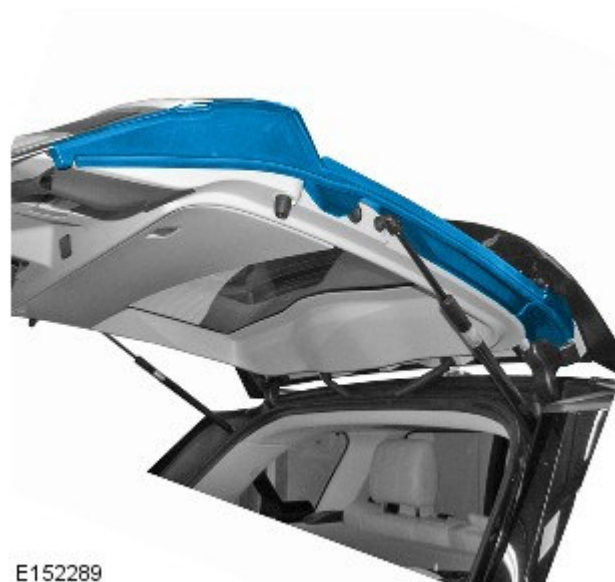
E152289

17. Check the upper anti-pinch moldings.

- Make sure that all clips are pushed securely into location.
- Repeat procedure to the other side.

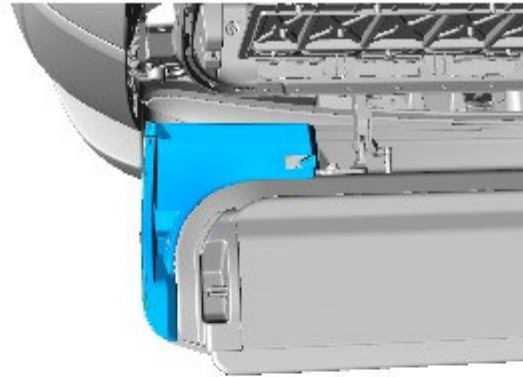
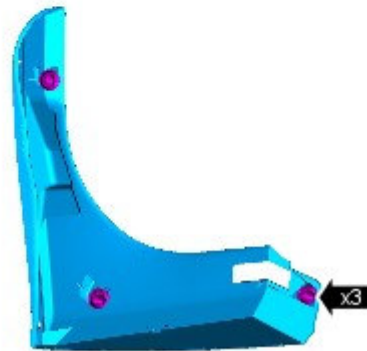
E146814

18. Check the lower anti-pinch moldings.

- Make sure that all clips are pushed securely into location.
- Repeat procedure to the other side.
