TECHNICAL BULLETIN

Q268NAS1

Service Action: Incorrect Color Front Door Side Vents

Range Rover (LG)
Model Year: 2013
VIN: DA105254-DA109681

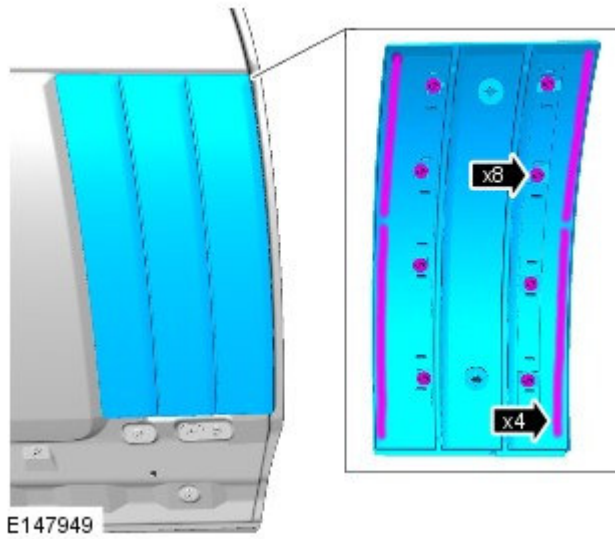
Situation: A limited number of vehicles within the listed VIN range may have been manufactured with the incorrect color front door side vents and not the correct specification Orkney Grey side vents.

Replace the front right door side vent:

- Remove the front right door side vent.
- Install eight (8) new clips to the new front right door side vent.

- Install double-sided tape to the new front right door side vent in the same position as the original side vent.
- Install the new front right door side vent.
