TECHNICAL BULLETIN  
Q268NAS2  
09 DEC 2013

Service Action: Incorrect Color Front Door Side Vents

**Range Rover (LG)**

**Model Year:** 2013  
**VIN:** DA105254-DA109681

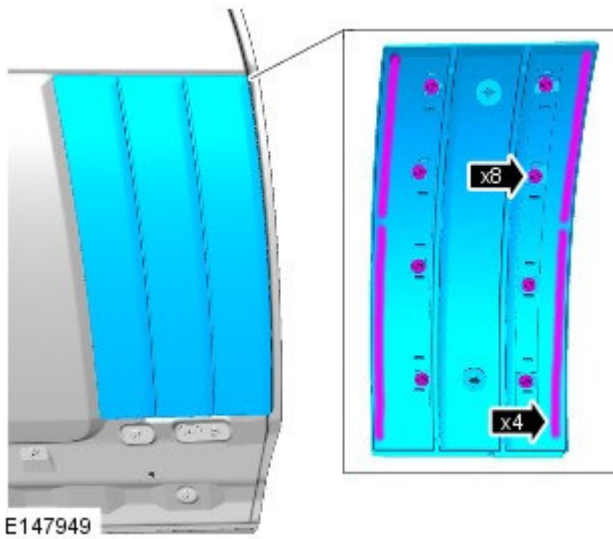
**Situation:** A limited number of vehicles within the listed VIN range may have been manufactured with the incorrect color front door side vents and not the correct specification Orkney Grey side vents.

**NOTE: Right-hand shown; left-hand similar.**

2. **NOTE:** Note the position of the tape on the removed side vent.

Replace the front right door side vent:

**3.** Carry out steps 1-2 to the front left door side vent.
