TECHNICAL BULLETIN

Q278NAS1
09 OCT 2013

Service Action: Battery Box Water Ingress

Range Rover (LG)
Model Year: 2013
VIN: DA100499-DA111073

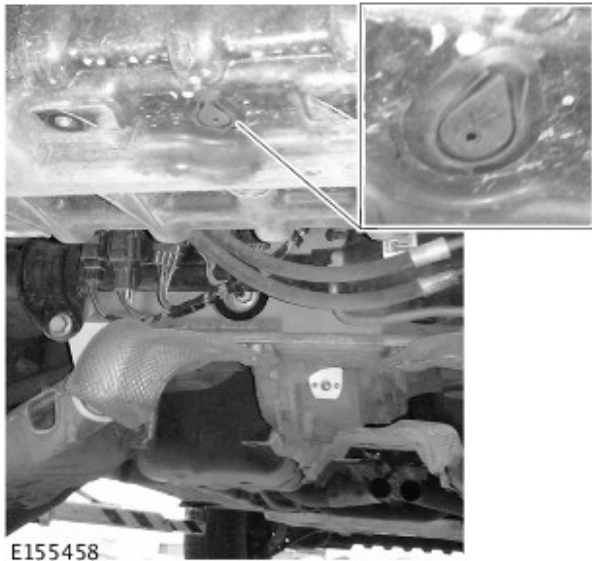
Situation: A limited number of vehicles within the listed VIN range may have an issue where the battery box within the spare tire well fills with water, disabling the vehicle's main battery.

**4. Remove the blanking plug.**

- If required, allow water to drain completely.

5. Install the new one-way valve into the removed blanking plug hole.
