# Service Bulletin

Bulletin No.: PI0176C

**Subject:** Sunroof Will Not Open/Close or is Noisy During Operation

**Models:** 2010-2014 Chevrolet Camaro  
Equipped with Sunroof (RPO CF5)

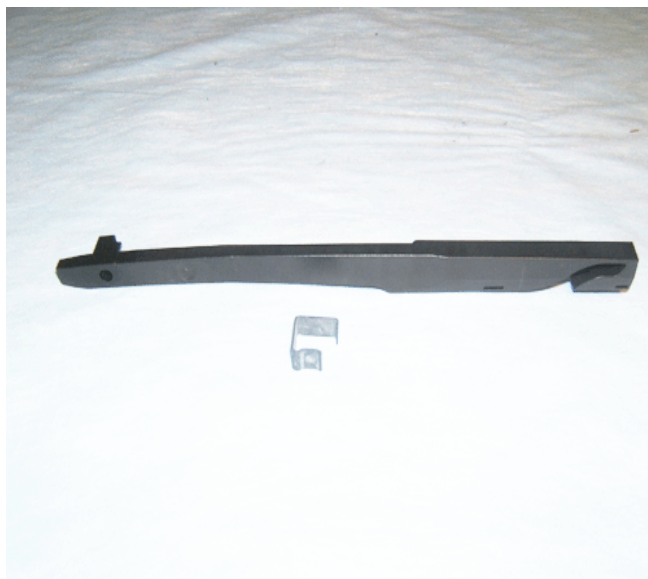
2494519

**Note:** Two guides and two retainer clips are supplied in the new service part kit. The left side guide/clip is shown in the above graphic. Always replace both guides and install the new clips when doing this repair.

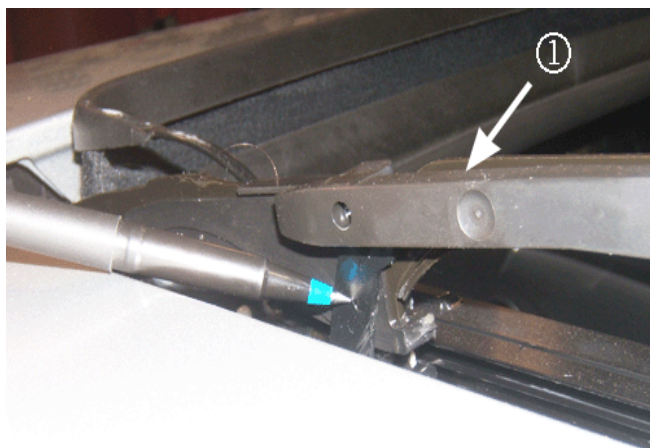
2494523

2. With the sunroof mechanism in the vent position, visually inspect the mechanism arm front levers (at pointer in the above graphic) on both sides of the sunroof assembly. Most commonly, the plastic guide (1) will break; however, if the metal arm lever shows any damage/fractures, the sunroof frame will need to be replaced.
