# Service Bulletin

Bulletin No.: PI0341B

**Subject:** Front Sunroof Sunshade Will Not Latch in Closed Position

**Models:** 2010-2011 Buick Enclave  
2010-2011 Chevrolet Traverse  
2010-2011 GMC Acadia  
2010 Saturn OUTLOOK  
Equipped with Sunroof RPO C3U  
and Built After August 1, 2009

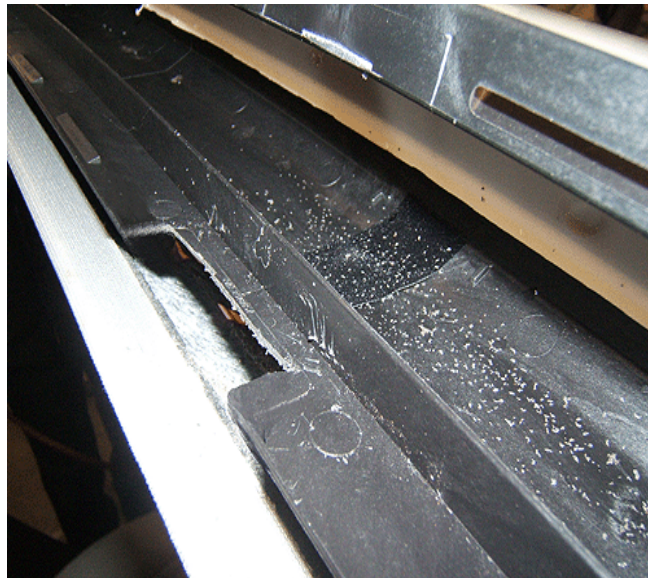
2552962

Some customers may comment that the front sunroof sunshade will not latch in the closed position. The molded-in sunroof sunshade striker on the sunroof module may be broken.

1. Check that the sunroof sunshade striker fits into where the broken striker was by placing the sunroof sunshade striker under the bottom of the front rail. File to fit if necessary.
2. Place the sunroof sunshade striker on the top surface of the front rail to locate the holes.
