Service Bulletin

Bulletin No.: PI0341C

Subject: Front Sunroof Sunshade Will Not Latch in Closed Position

Models: 2010-2014 Buick Enclave
2010-2014 Chevrolet Traverse
2010-2014 GMC Acadia
2010 Saturn OUTLOOK
Equipped with Sunroof RPO C3U
and Built After August 1, 2009

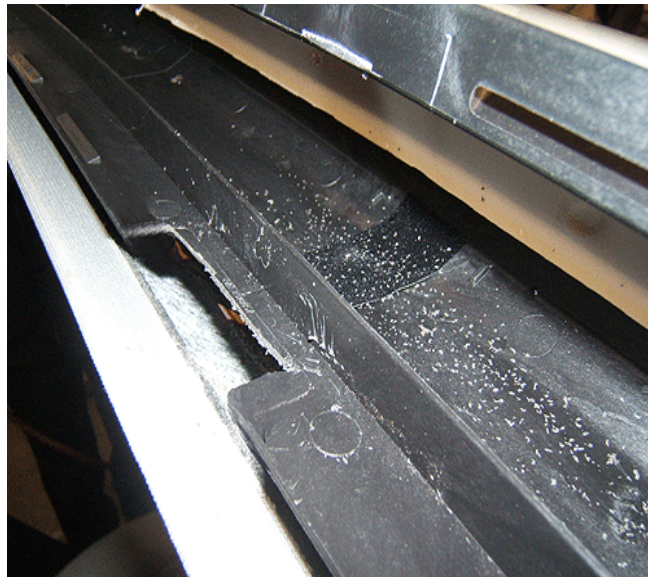
2552962

Some customers may comment that the front sunroof sunshade will not latch in the closed position. The molded-in sunroof sunshade striker on the sunroof module may be broken.

1. Check that the sunroof sunshade striker fits into where the broken striker was by placing the sunroof sunshade striker under the bottom of the front rail. File to fit if necessary.
2. Place the sunroof sunshade striker on the top surface of the front rail to locate the holes.
