# Service Bulletin

Bulletin No.: PI0595A

**Subject:** Information on Floor Mat Retainer Orientation

**Models:** 2011-2013 Buick Enclave  
2011-2013 Chevrolet Traverse  
2011-2013 GMC Acadia

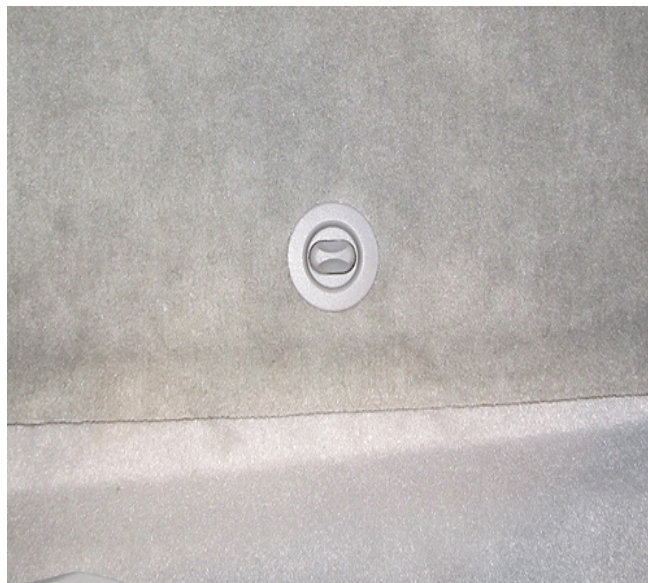
A technician or customer may comment that the floor mat(s) will not properly install, or engage with, the carpet side mat retainer. This condition could occur at any of the front or second row floor mat locations.

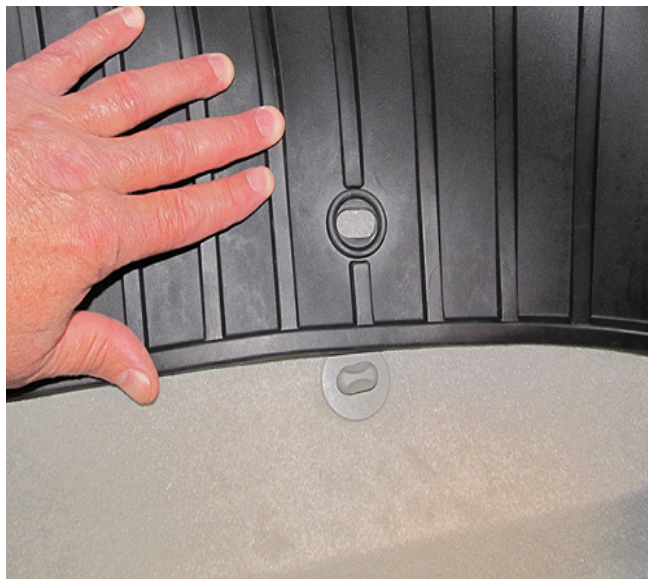
2730210

The opening on the floor mat is oriented for the carpet side quarter turn retainer to be in cross-car position when the mat is installed in the vehicle. Proper engagement of the floor mat is achieved when the retainer knob is rotated a quarter turn to the fore/aft position. If the orientation of the mat/retainer is not allowing proper engagement, the orientation of the carpet side retainer must be corrected.
