Service Bulletin

Bulletin No.: PI0625A

Subject: Hydraulic Pump Leaking Fluid in Area of Rear Seat, Floor or Trunk, Convertible Top Inoperative or Noise

Models: 2011-2014 Camaro Convertible

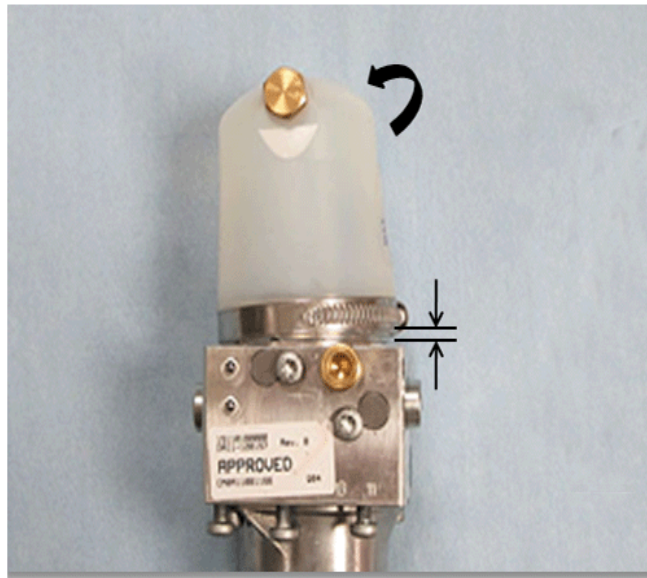
2741238

2. Inspect the fluid reservoir for correct installation/position on the pump assembly. The graphic above shows an example of the reservoir tipped and not properly seated, which exposes a gap where fluid can leak.

Important: When fully seating the reservoir, make sure the original position of the reservoir and the retaining clamp is maintained and that neither is rotated in relation to the pump.

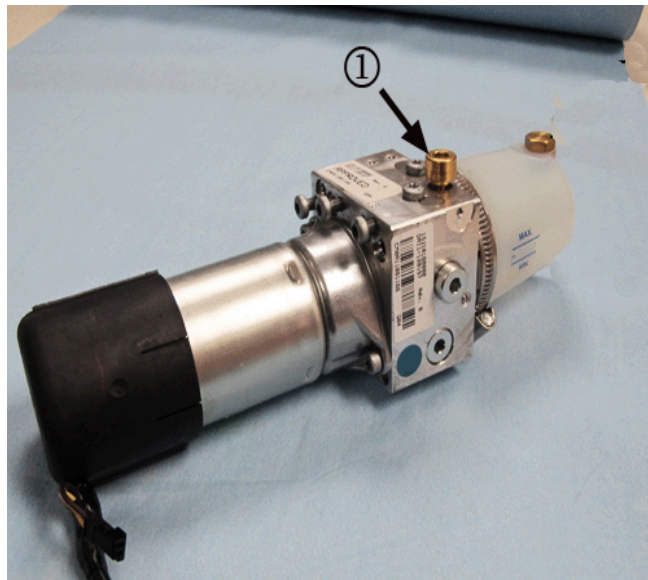
2744331

Important: When checking for fluid leaks, pay close attention to the manual release valve (1). A maximum of one and a half revolutions is recommended when opening this release valve. If for any reason the valve was turned out more than one and a half revolutions, the potential for damaging the valve seal could exist. This valve seal is NOT serviceable, so once the release valve is fully closed, if any fluid leak is evident at the valve location, the folding top pump assembly would have to be replaced.

Note: Recommended torque specifications for the reservoir fill plug is 2 N•m (18 lb in) and for the manual release valve is 4 N•m (35 lb in).
