# Service Bulletin

Bulletin No.: PI0647A

**Subject:** Poor Engine Performance and/or DTCs Set After Partial Engine Replacement

**Models:** 2011-2014 Chevrolet Cruze  
2012-2014 Chevrolet Sonic  
Equipped with Engine RPO LUW

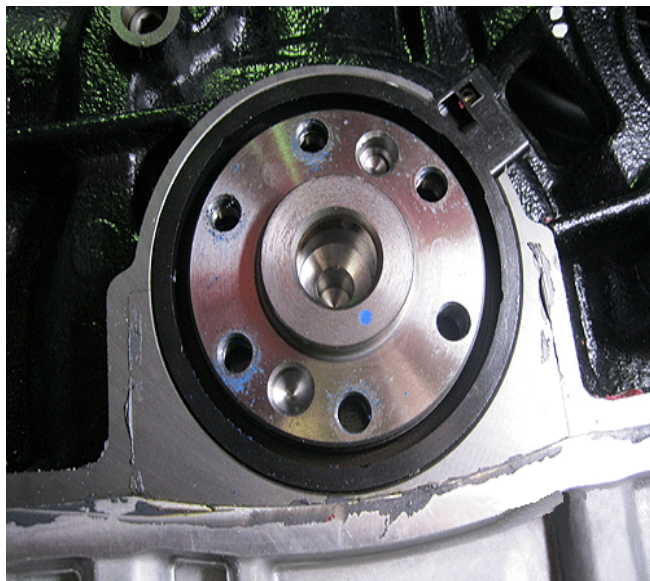
2751128

Most components that need to be transferred are very obvious. One part that is not obvious is the crankshaft reluctor wheel. This needs to be transferred from the old engine and installed onto the new engine.

The reluctor wheel is located between the flywheel and the crankshaft. Once the flywheel is removed, the reluctor wheel can be transferred to the rear of the new engine and the flywheel can be installed to retain the reluctor. Failure to transfer this part will cause the engine to run poorly and set DTCs.  
Additional Keywords: DTC P0335 P0336

When a new partial engine is needed for replacement, it is very important to transfer all parts from the old engine to the new engine before installation of the new engine.
