Service Bulletin

Bulletin No.: PI0659A

Subject: Groan, Squeak or Rubbing Type Noise When Turning Steering Wheel

Models: 2010-2013 Buick LaCrosse
2012-2013 Buick Regal
2013 Chevrolet Malibu

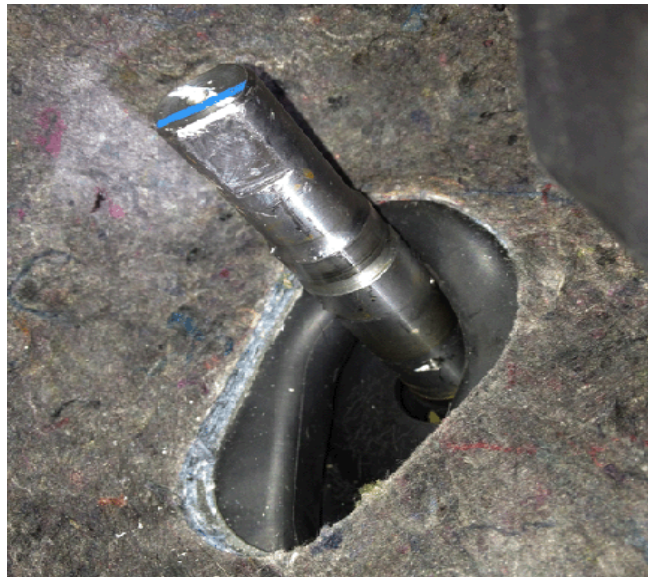
Some customers may comment on a rubber squeak type noise when turning the steering wheel. This condition may be caused by the seal for the intermediate shaft, located at the front of dash, rubbing on the rotating intermediate steering shaft. Refer to the pictures above. On electronic power steering (EPS) equipped vehicles, the EPS wire harness bracket may be contacting the steering column seal.

Technicians should inspect the steering column seal for proper installation by repositioning the inner intermediate steering shaft boot assembly to gain access. Inspect the seal at the front of the dash where the intermediate steering shaft passes through from the steering gear. Ensure that the seal is centered in the opening and around the intermediate steering shaft as shown above. If the seal is out of position, replace the steering column seal following the steps below.
