Service Bulletin

Bulletin No.: PI0685B

Subject: GM Accessory and Camaro Transformer High Wing Spoiler Center High Mount Stop Lamp (CHMSL) Cracking Around Fasteners

Models: 2010-2013 Chevrolet Camaro (U.S. and Canada Only)

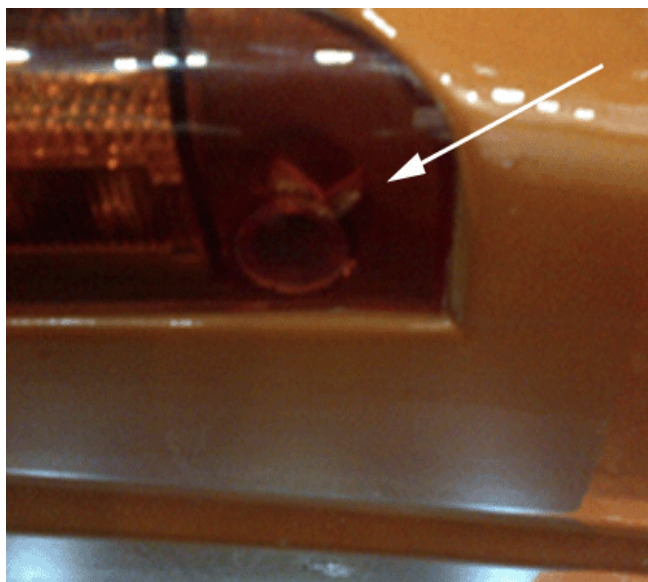
2775515

Some customers may comment on the CHMSL developing cracks in the area around the fasteners.

DO NOT REPLACE THE SPOILER for this condition.

Replace the CHMSL high mount stop lamp using the following procedure:
