Bulletin No.: PI0686A

Service Bulletin

Subject: Front Seat Lateral Movement, Clunk, Squeak, Click Noise or Shift While Cornering

Models: 2012-2014 Buick Verano
2011-2014 Chevrolet Cruze
Equipped with RPO A53, ADS, AH4 6-Way Power or 6-Way Manual Driver or Passenger Seat

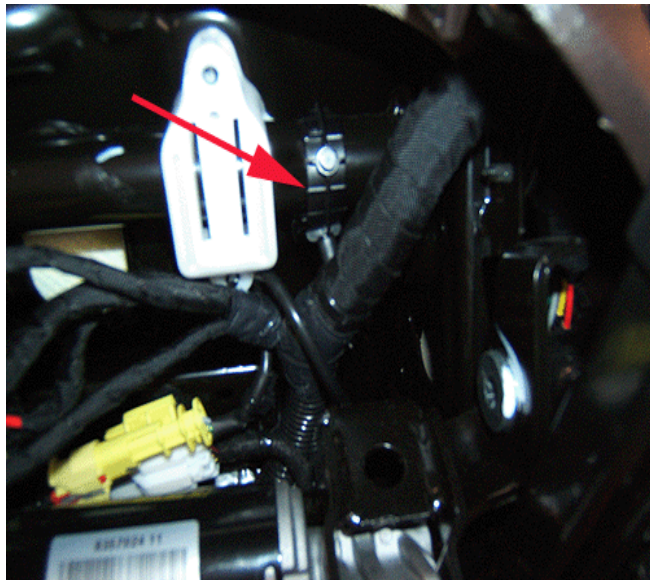
2774766

5. On vehicles equipped with power seats, there may be a wire harness attached to the crossbar where the clip is to be installed.

- If there is a harness clipped to the seat crossbar, remove the harness and clip from the crossbar.
- Cut the clip off of the harness.
- Use a second wire tie to re-secure the harness to the new seat clip. Ensure the harness does not come into contact with the connector area of the first wire tie.
