Service Bulletin

Bulletin No.: PI0718B

Subject: Audio System Speaker Rattle, Buzz Noise, Poor Sound When Playing Radio or Other Music Source

Models: 2007-2013 Cadillac Escalade EXT
2007-2014 Cadillac Escalade, Escalade ESV
2007-2013 Chevrolet Avalanche, Silverado
2007-2014 Chevrolet Suburban, Tahoe
2007-2013 GMC Sierra
2007-2014 GMC Yukon, Yukon XL, Yukon Denali, Yukon Denali XL

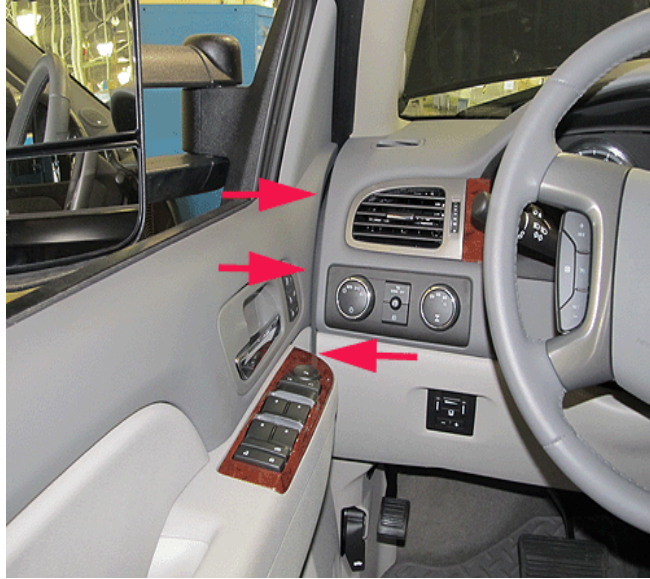
2811993

An interface may cause a rattle or buzz (for example, between a door and instrument panel).

- To better identify the location, open the door and determine if the buzz or rattle follows the door. This may be caused by loose door trim or water deflector contact with the trim. Refer to **Door Trim/Water Deflector Rattle** below.
- Determine if a rattle is heard between the instrument panel and door. This may be caused by contact between the instrument panel and the door trim when the door is closed. If the noise goes away when the door is opened, inspect the trim panel on the door to ensure it is in the correct position. Also, inspect the snap-on trim panels on the instrument panel ends to ensure they are fully engaged into the instrument panel.
- If the rattle or buzz is determined to be coming from the instrument panel, inspect for loose panels, screw covers or contact between trim panels such as an A pillar to instrument panel interference.

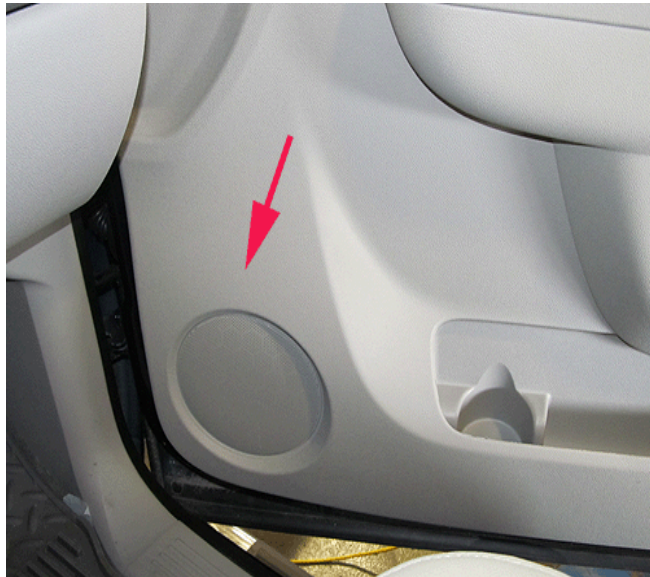
2811994

If the rattle is heard within the door trim, depress the trim with your hand. If the sound changes or the rattle/buzz decreases when pressure is applied, follow the steps below.
