Service Bulletin

Bulletin No.: PI0776A

Subject: Left Front Fender Liner Rattle, Ticking or Flutter Noise While Driving

Models: 2012-2013 Chevrolet Impala

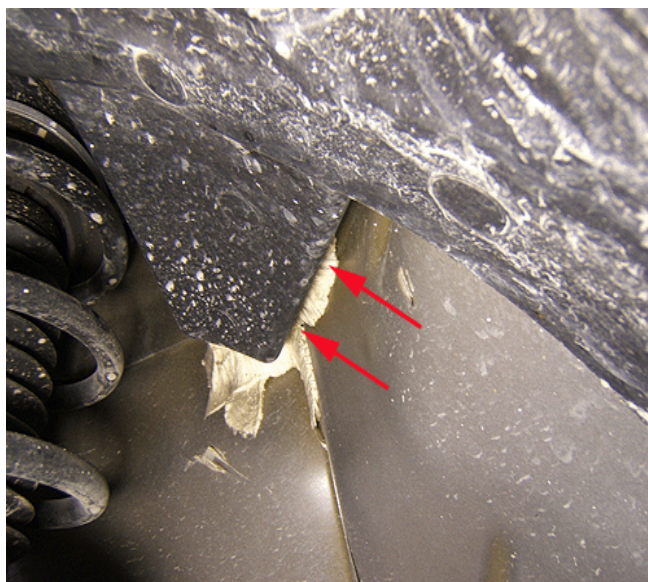
2891248

Some customers may comment on a noise coming from the left front of the vehicle while driving at speeds above 65 km/h (40 mph). This condition may be described as a rattle, flutter or ticking type noise.

This noise may be caused by the left front plastic fender liner (splash shield) making contact with the body structure.
