Service Bulletin

Bulletin No.: PI0807B

Subject: Exhaust Rattle Noise

Models: 2011-2013 Chevrolet Camaro Convertible
Equipped with V8 Engine (RPO L99)

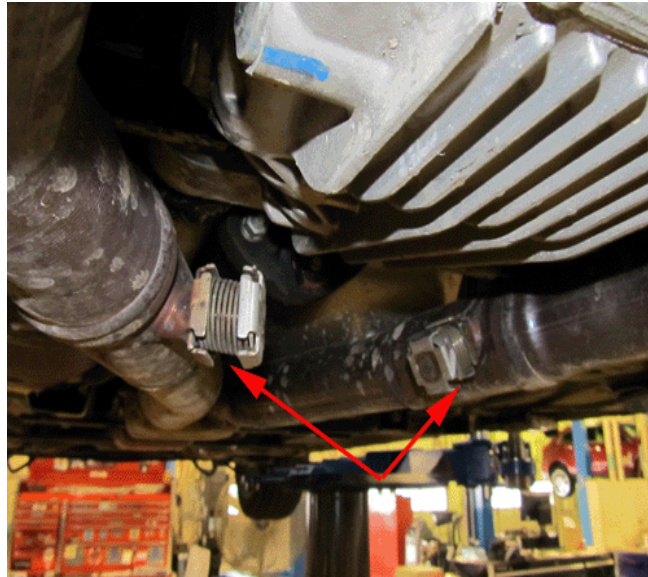
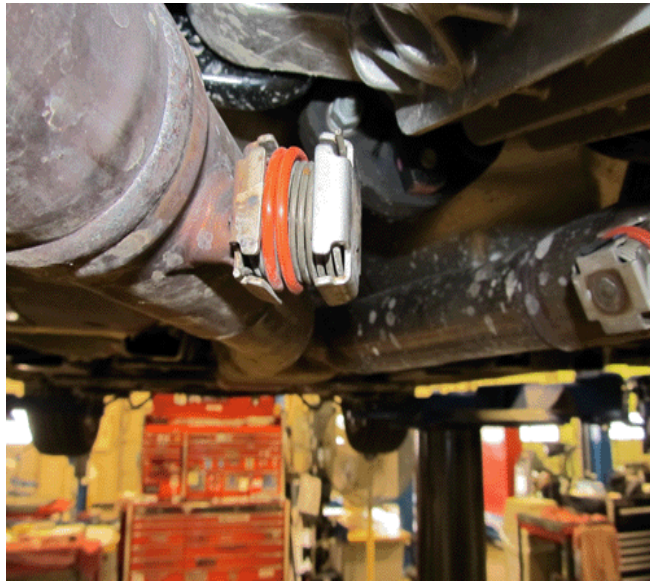
2898703

Some customers may comment on an exhaust rattle or noise when at idle or slow vehicle speeds up to 1300 engine rpm.

The spring in the exhaust valve may be causing the exhaust to rattle or make noise.

Technicians should follow the procedure below and install two silicone O-rings over each of the exhaust valve springs to dampen the rattle.

1. Raise the vehicle.
2. Install two O-rings onto the left exhaust valve spring.
3. Install two O-rings onto the right exhaust valve spring.
4. Lower the vehicle.
