Bulletin No.: PI0828A

Service Bulletin

Subject: Inspection and Repair Guidelines for Dust Intrusion into Passenger Compartment

Models: 2010-2013 Chevrolet Equinox
2010-2013 GMC Terrain

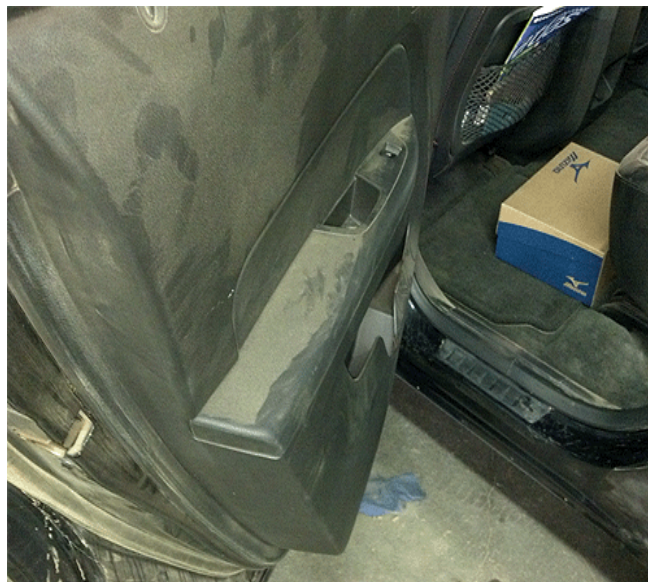
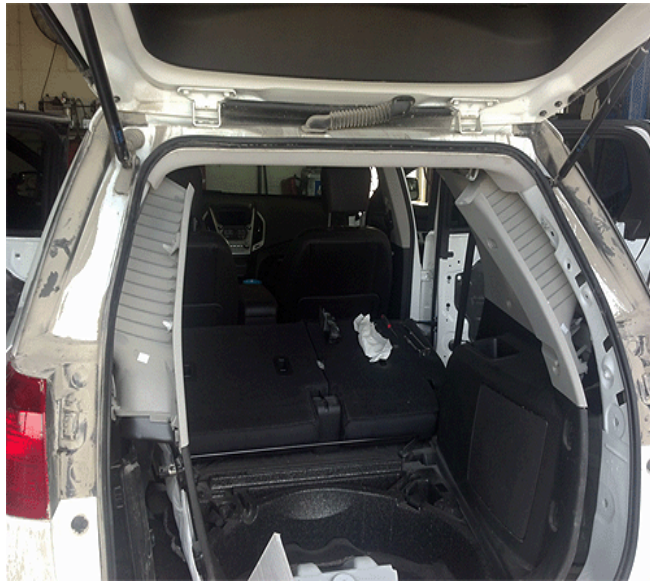
Some customers may comment that excessive dust is entering into the passenger compartment through the side doors or rear liftgate areas. This is usually found to occur when the vehicle is driven in high dust areas. Examples of this condition are shown in the graphics below.

The cause of this condition may be that the dust/debris is working past the side door or liftgate sealing surfaces.

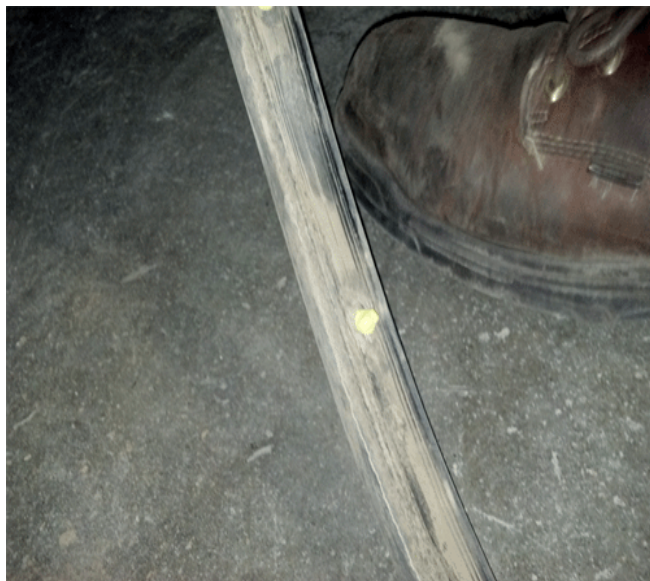
2914201

Note: A vehicle will sometimes show evidence of dirt/dust being pulled past the backside of the rocker moldings as shown above. A double sided tape is added to the moldings to help eliminate this condition.
