# Technical Bulletin

63 13 01 April 26, 2013 2033699

### Paint Chafe between Rear Bumper Cover and Fender

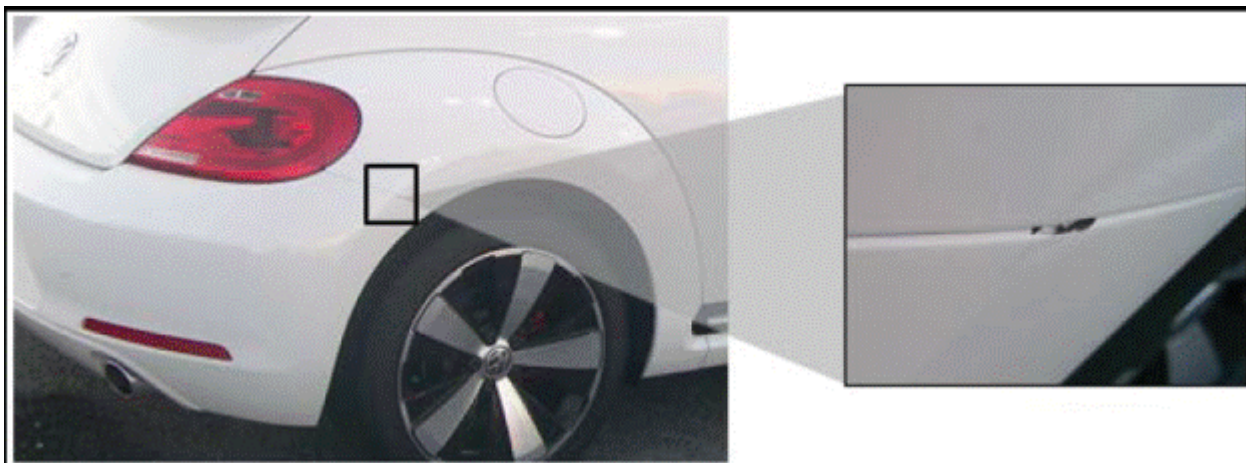
Figure 1

Customer may identify a paint chafe between rear bumper cover and fender (quarter panel, figure 1).

Contact friction between rear bumper cover and fender due to improper fit.

Dimensional change to the rear bumper cover and addition of expanding rivet address the concern in production as of the following VIN's:

- Remove rear tail lamps. See Repair Manual group 94 in Elsa.
- Remove rear bumper cover. See Repair Manual group 63 in Elsa.
- Repair paint chafe area.
