Technical Bulletin

91 13 19 September 13, 2013 2023500 Supersedes T. B. V911211 dated May 23, 2012 to include note about SD card ordering.

Update Programming Radio, RCD 510 (Premium 8) for Various Functionality Concerns

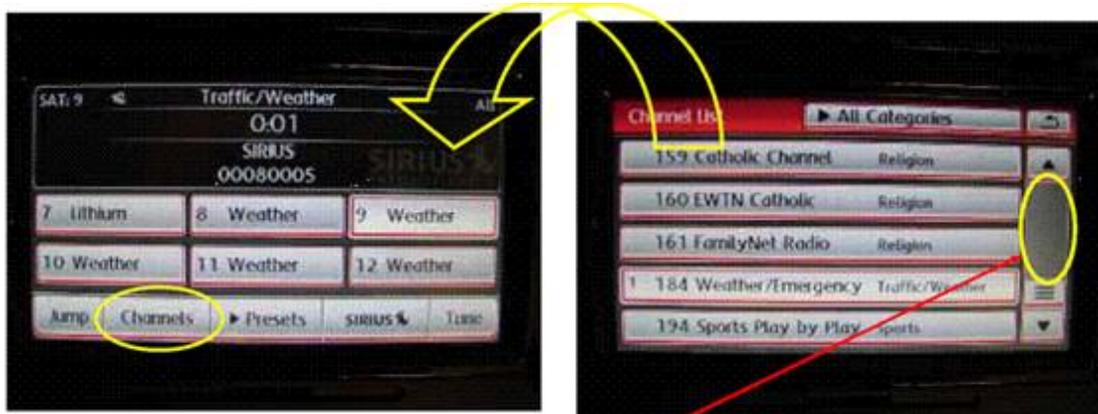
- Loss of presets
- Loss of speed dependent volume settings
- “Gong” displayed on radio when using satellite radio
- Sporadic loss of sound in AM mode
- After selecting “Channels” on screen 1 and scrolling on screen 2, the unit will sometimes go back to screen 1

Screen 1

Screen 2

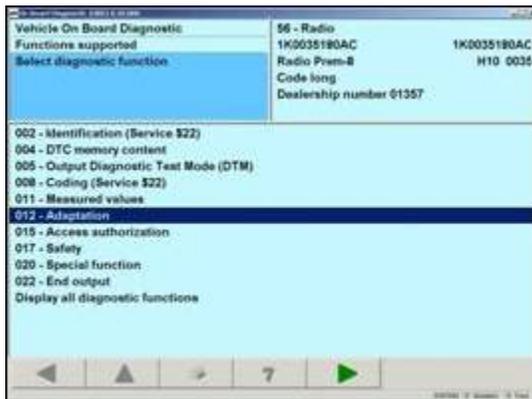
Deactivating Engineering Mode

Engineer mode needs to be deactivated or the unit will run slower.

- Select **Vehicle Self - Diagnosis**
- Select **On Board Diagnostics (OBD)**
- Select **56 - Radio**
- Select **012 - Adaptation**
- Enter channel 50 and select **Q**
- Change value from 1-> 0 and select **Save**
- Select **Accept**
- Left arrow twice and exit out of **56 - Radio**
