Service Bulletin

Bulletin No.: PI0856A

Subject: Flutter or Rattle Noise Heard from HVAC Vent

Models: 2012-2013 Chevrolet Impala
Vehicles Built After February 15, 2012

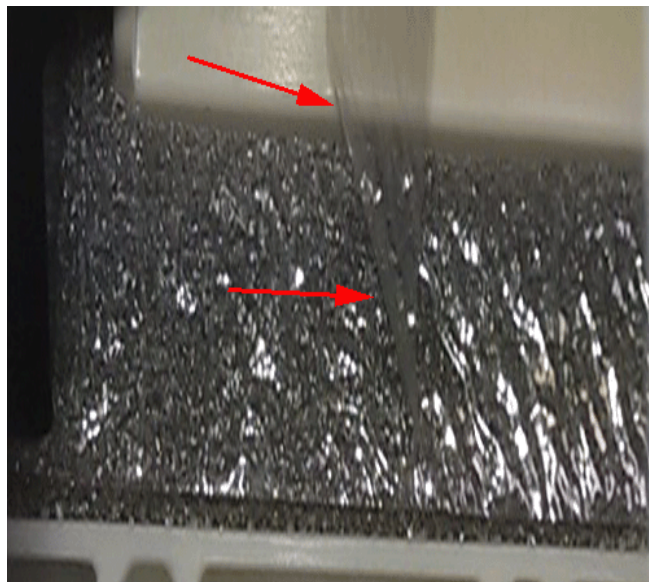
2968367

Some customers may comment on a flutter or rattle noise heard from the HVAC when using the heat or A/C. This condition may be caused by loose mylar on the foam seal under the HVAC vent doors.

Note: Mylar strip peeling off the foam as shown in the illustration above.

Follow the procedure below for removing the mylar strip off the foam seal under the HVAC vent doors:

1. Remove the instrument panel carrier. Refer to Instrument Panel Carrier Replacement in SI.
2. Remove both recirculation and mode door actuators. The technician will be able to manually open the doors to get access to the foam.

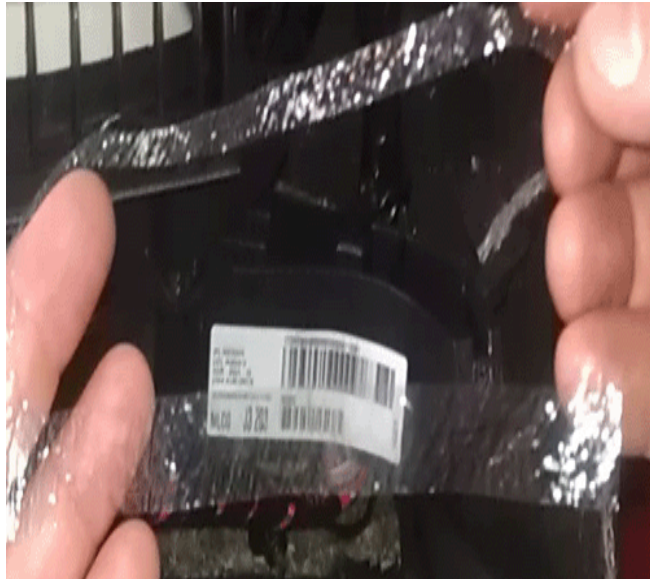
2968370

Note: Mylar strip removed from the foam as shown in the illustration above.

3. Using a hook pick type tool, remove the piece of mylar off the foam through the vents under the HVAC vent doors.
