Service Bulletin

Bulletin No.: PI0885

Subject: Inoperative Heated Steering Wheel Operation after Replacing Steering Wheel

Models: 2012 Cadillac SRX

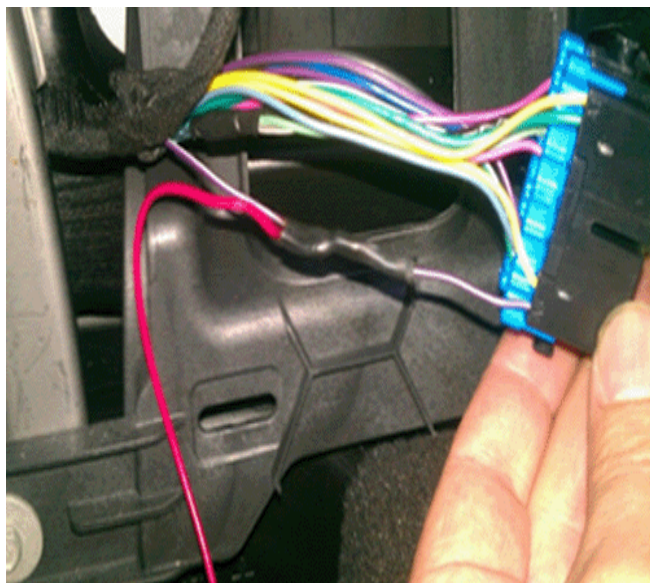
3254430

Note: 23 gauge wire being spliced to purple/white wire on connector X211 as shown in illustration above.

3. Using 23 gauge wire, splice the wires together with the purple/white wire from connector X211 and route to connector X1 terminal cavity 8 as shown in the illustrations above.
4. Reinstall the left side front floor console extension.
5. Reinstall the driver knee bolster panel.

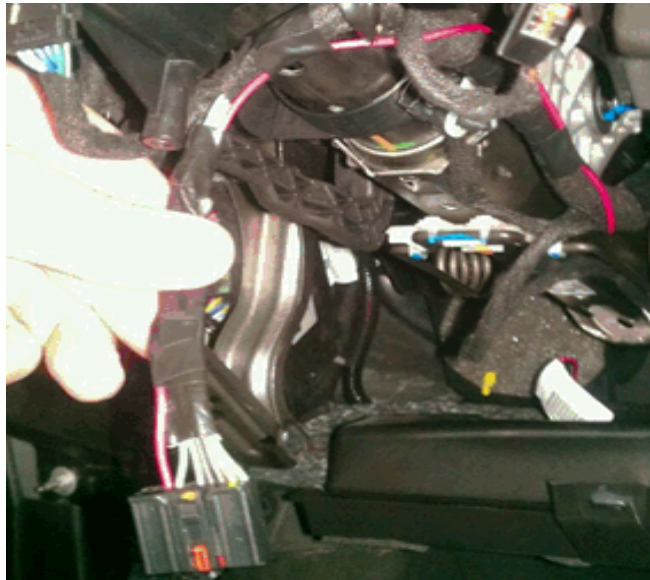
3254732

Note: 23 gauge wire routed to connector X1 with new wire in terminal cavity 8 as shown in illustration above.
