# Service Bulletin

Bulletin No.: PI0886

**Subject:** Electric Power Steering System Squeak Noise/Whining or Sticking when Turning Steering Wheel

**Models:** 2012-2013 Chevrolet Cruze, Volt  
Equipped with Electronic Power Steering

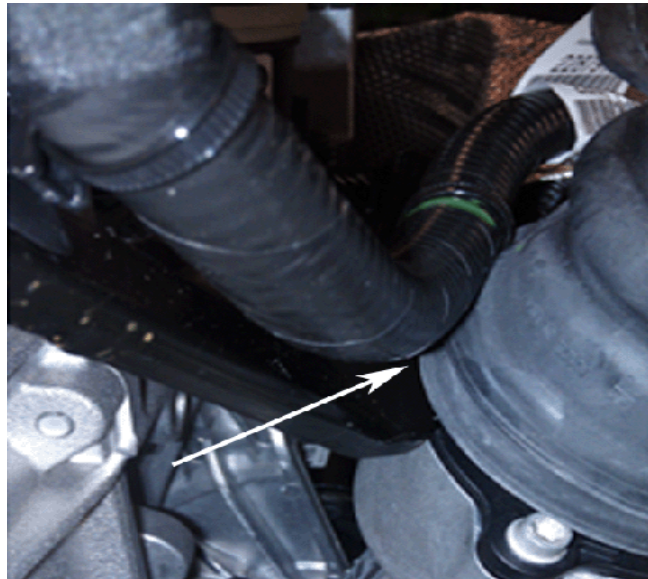
3225896

Some customers may comment on a rubber squeak type noise when turning the steering wheel.

This condition may be caused by the electronic power steering (EPS) wire harness bracket contacting the steering column seal.

Technicians should inspect the EPS wire harness bracket and make sure that the bracket is not contacting the steering column seal. If contact is observed, manually adjust the EPS bracket to obtain an 8-12 mm (0.31-0.47 in) clearance from the steering column seal.
