Service Bulletin

Bulletin No.: PI0888

Subject: Sunroof Seal Misshaped or Raised Up Along Front Edge of Sunroof Opening

Models: 2013 Cadillac ATS
Equipped with Sunroof (RPO CF5)

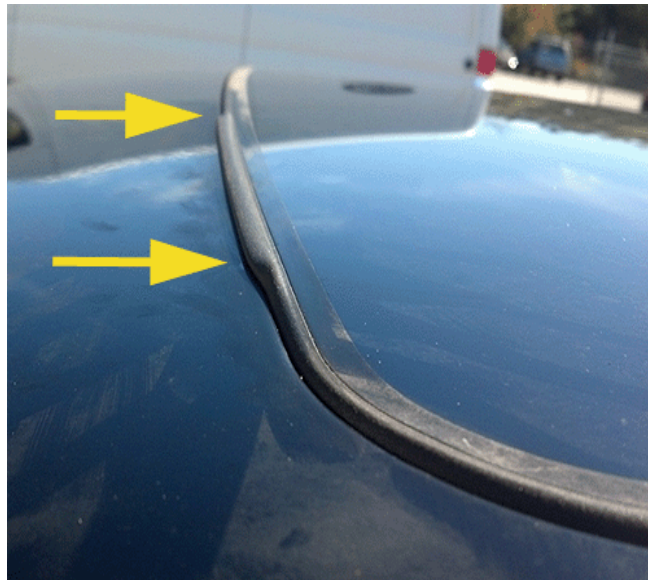
3258224

Some customers may comment that the front edge of the sunroof glass seal may be puckered, misshaped or raised up.

This condition may be caused by the glass sunroof panel being out of adjustment.

To correct the condition, adjust the glass sunroof panel to the sunroof opening. Refer to Sunroof Window Height and Opening Fit Adjustment in SI.

It should not be necessary to replace the seal.
