Service Bulletin

Bulletin No.: PI0891

Subject: Starter Positive Battery Cable Terminal Contact Repair

Models: 2012-2013 Chevrolet Sonic
Equipped with 1.4L Turbo Engine (RPO LUV)
Built Prior to October 29, 2012

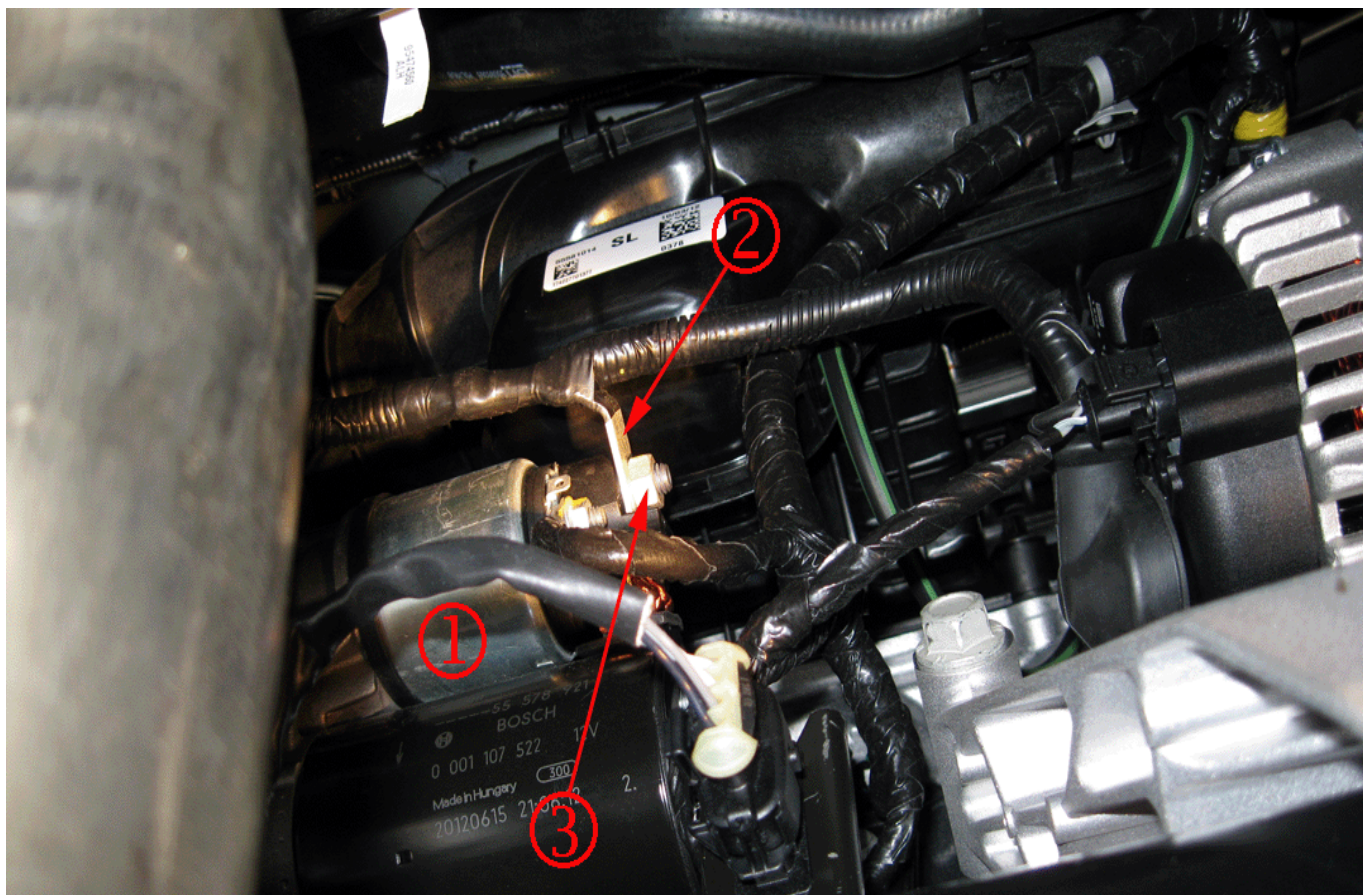
3136612

3. Locate the starter solenoid (1), positive battery cable terminal (2) and the positive battery cable fastener (3).
