Service Bulletin

Bulletin No.: PI0897

Subject: Sunroof Rattle Noise When Glass Open and Driving Vehicle

Models: 2013 Cadillac ATS
Equipped with Sunroof (RPO CF5) and Built Prior to VIN Breakpoint D0149142

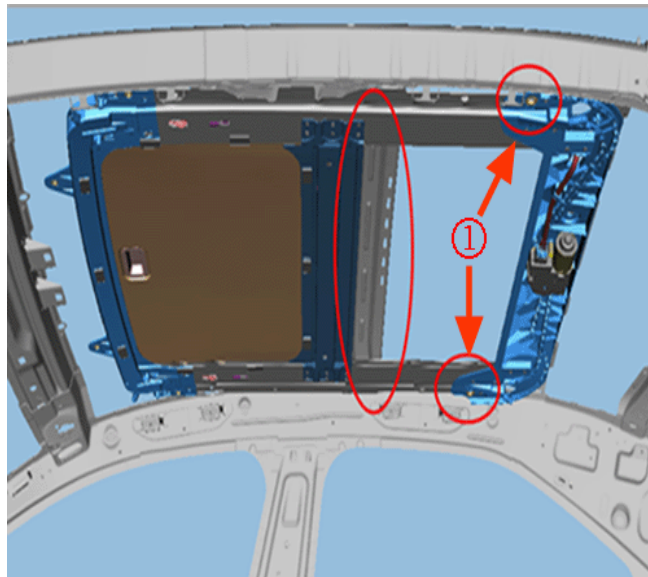
3272276

The cause of this condition may be that, during production, the rear of the sunroof module was installed too high when the two rear leveling features (1) were not properly adjusted. When the sunroof glass is open, the distance between the glass and the roof structure #2 bow (shown circled above) is too narrow and contact of the glass to the roof bow may occur.

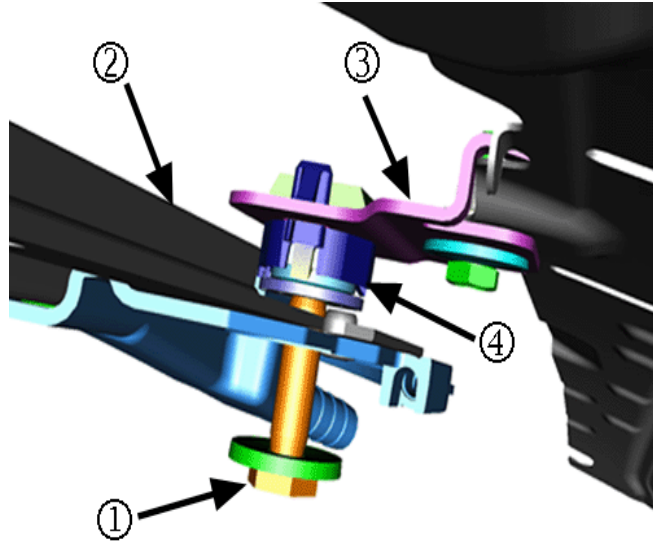
3272280

The two rear bolts (1) of the sunroof module (2) thread into a bracket (3), mounted to the roof structure on each side, which contain a unique leveling nut mechanism (4).

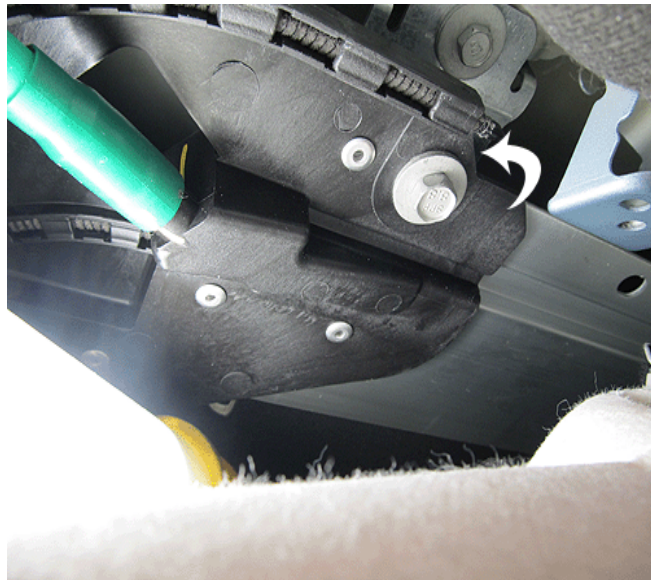
3272283

This leveling nut is sandwiched between the bracket and the topside of the sunroof frame, so it is not visible when the sunroof module is installed. A right rear view of the module is shown in the graphic above.

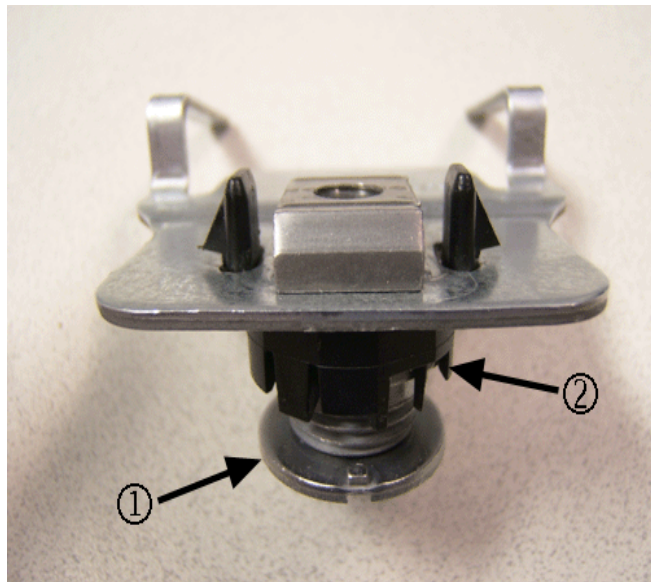
3272285

The washer insert (1) of the leveling nut has a reverse thread. Turning it clockwise will increase the gap between the washer and housing (2) and turning it counterclockwise decreases the gap. By design, when the sunroof bolt is installed into the leveling nut, the washer insert will thread downward and open the gap until the washer contacts the topside of the sunroof frame.

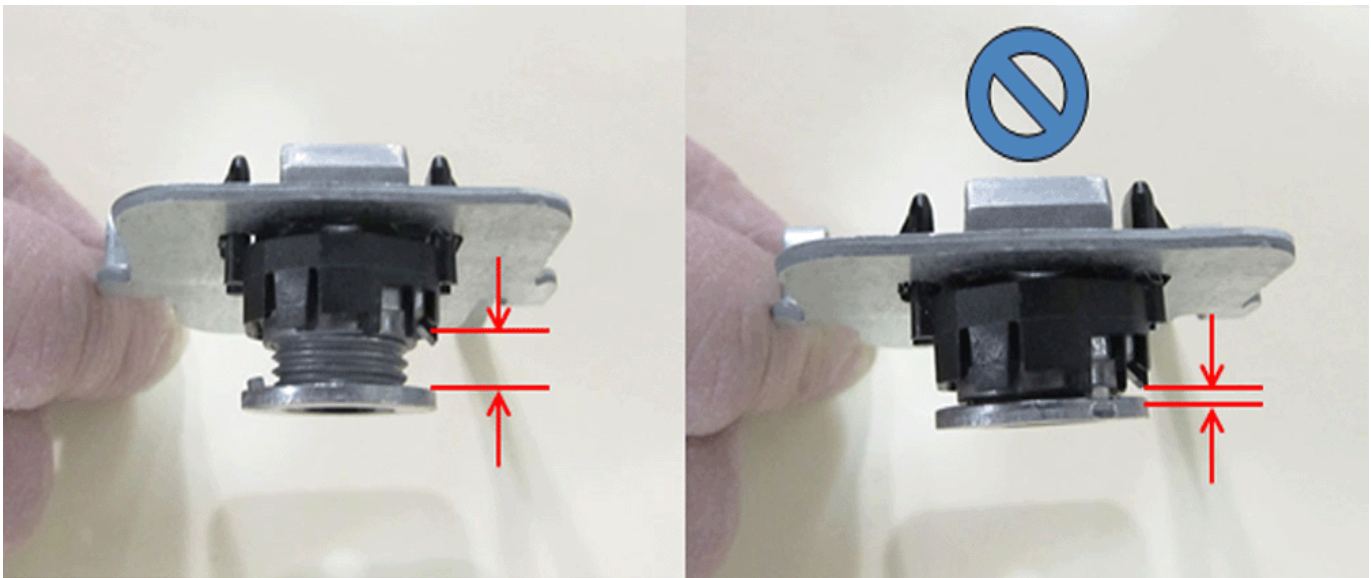
3272290

Design intent is to maintain a 5 mm (0.20 in) gap in the leveling nut during installation of the sunroof. The graphics above show the correct/incorrect gap.

Verify the condition, then properly adjust the two rear sunroof leveling nuts following the steps below:
