# Service Bulletin

Bulletin No.: PI0900

**Subject:** Rear Door Exterior Paint Finish Chipped, Cracked or Scratched Along Lower Rear Corner of Rear Side Door Reveal Molding

**Models:** 2012-2013 Cadillac Escalade ESV, Escalade EXT  
Built Between April 1, 2012 and November 2, 2012

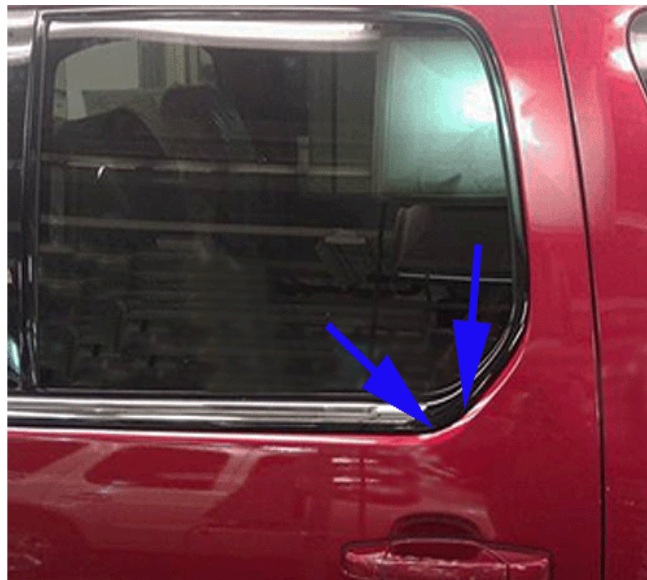
3238860

Some customers may comment that the exterior paint finish is chipped, cracked or scratched around the lower rear corners of the rear side door window reveal molding.

The paint damage may appear either as single point chip marks and/or extended chips or scratches.

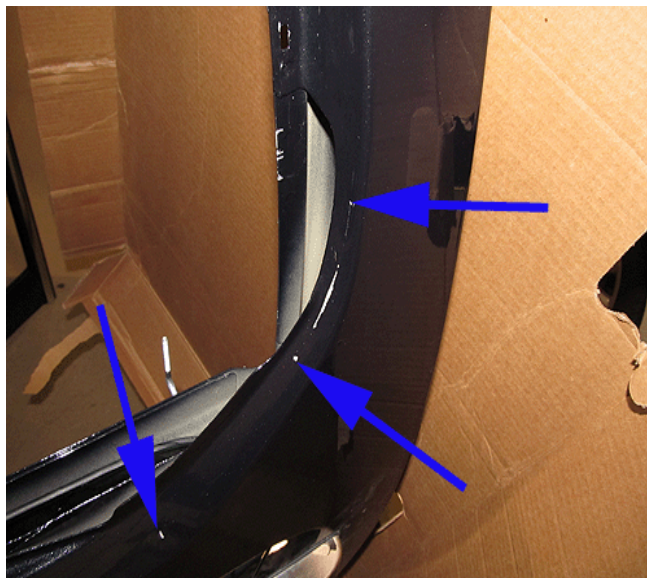
3238863

The single point chips may occur when the molding is installed during manufacturing. The molding has stiffening ribs on the back that may chip the finish during installation (shown with door trim removed).

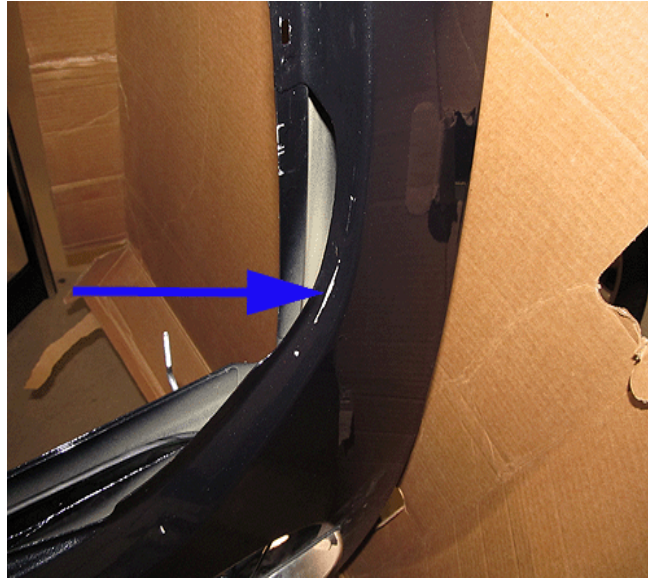
3238867

The more extensive damage may be the result of inadequate clearance between the molding and the door (shown with door trim removed).

As the molding expands when exposed to elevated temperatures, it may contact the finish and scratch or chip the paint.
