Service Bulletin

Bulletin No.: PI0903A

Subject: Exhaust Leak and/or Service Vehicle Soon (SVS) On and DTC P0171 Set

Models: 2013 Chevrolet Cruze, Sonic
2013 Chevrolet Trax (Canada Only)
Equipped with 1.4L Engine (RPO LUV)

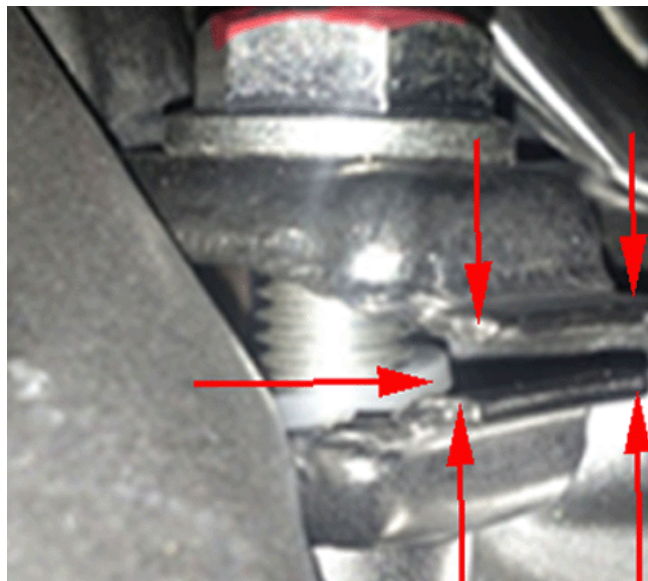
3271117

This condition may be caused by excessive amount of glue used by the supplier to retain the gasket before mounting the converter to the manifold. Hardened glue may have filled the sealing gap, which restricts the V-band clamp to draw both flanges together completely.

Note: The illustration above shows the ends of the V-band clamp with the gap.

2. Unscrew the fastener on the V-band clamp a total of several rotations.
3. Using a screwdriver, pry the clamp apart and make sure that both halves of the clamp are loose and not stuck to either flange.
4. Tighten the bolt.

Tighten the bolt to 13 N•m (115 lb in).

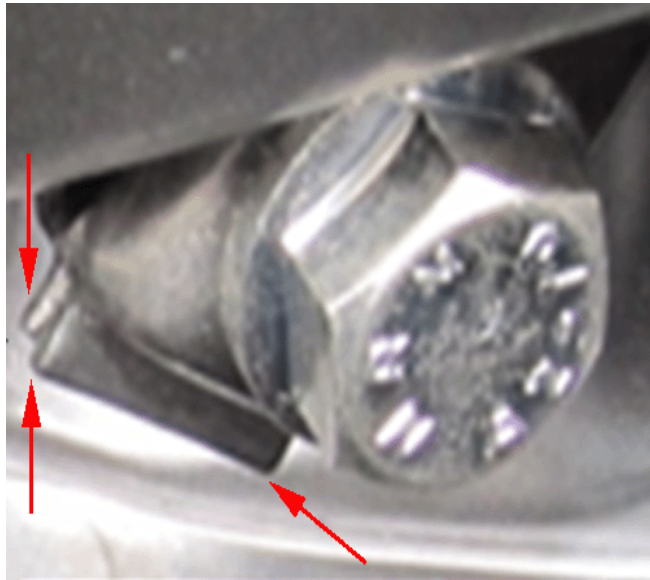
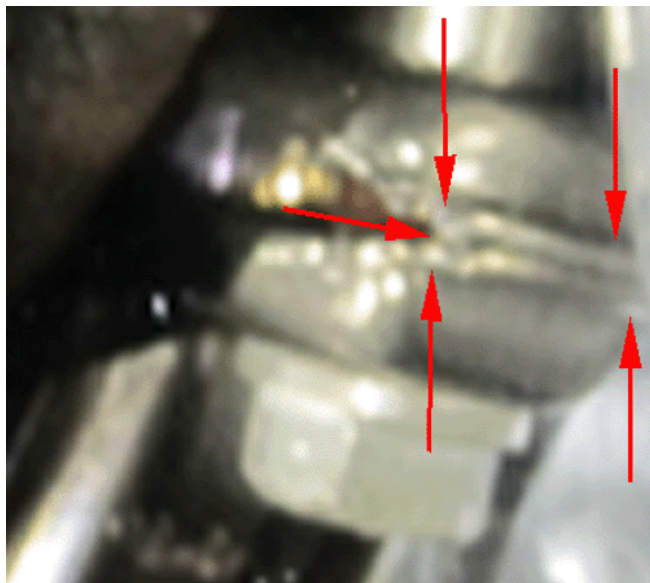
Note: The illustrations above show the ends of the V-band clamp with both flanges together completely.
