Service Bulletin

Bulletin No.: PI0907A

Subject: Check Engine Light On with DTC P1101 Set

Models: 2013 Buick Encore
2011-2013 Chevrolet Cruze
2012-2013 Chevrolet Sonic
2013 Chevrolet Trax
Equipped with 1.4L Engine (RPOs LUJ, LUV)

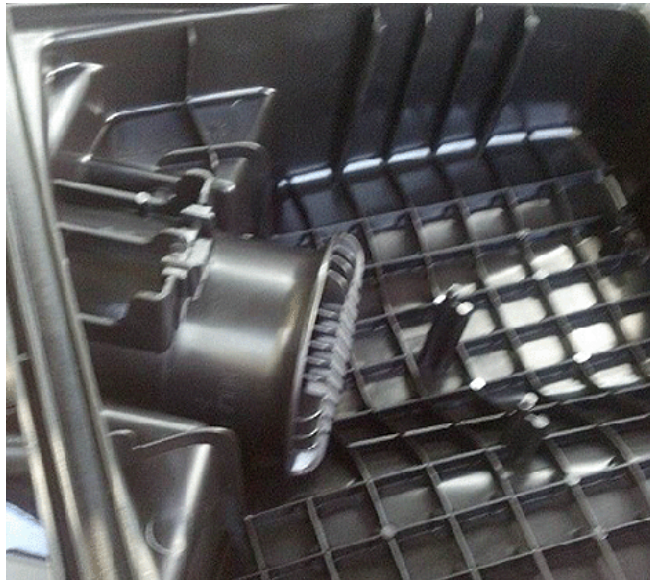
3581987

A missing or mispositioned air baffle in the air cleaner box could cause the TPS readings to be low and the vehicle setting P1101. Verify the air baffle is in the proper place before continuing with diagnostics. Refer to the pictures below.
