# Service Bulletin

Bulletin No.: PI0914

**Subject:** BYOM XM Radio Inoperable, Service Camera Message On, No Bluetooth Function, Siri Eyes Free Software, BringGo and TuneIn Radio Applications Added – GMNA Only

**Models:** 2013 Chevrolet Sonic, Spark, Trax  
Equipped with Uplevel Radio (RPO UF7)

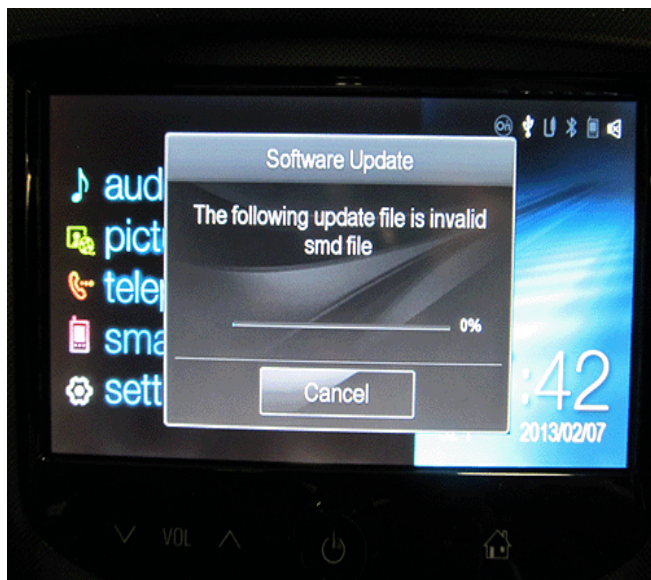
3286662

8. If you see the message as shown above "The following update file is Invalid SMD file," continue to the next step. Otherwise, skip to Step 14.
