# Service Bulletin

Bulletin No.: PI0914A

**Subject:** MyLink Radio – XM Inoperable, Service Camera Message On, No Bluetooth Function, Software Enhancement Update – GMNA Only

**Models:** 2013 Chevrolet Sonic, Spark, Trax  
Equipped with Uplevel Radio (RPO UF7)

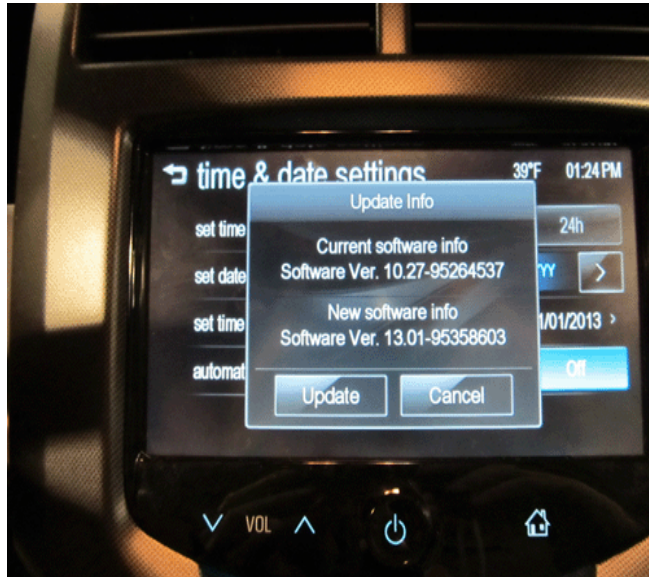
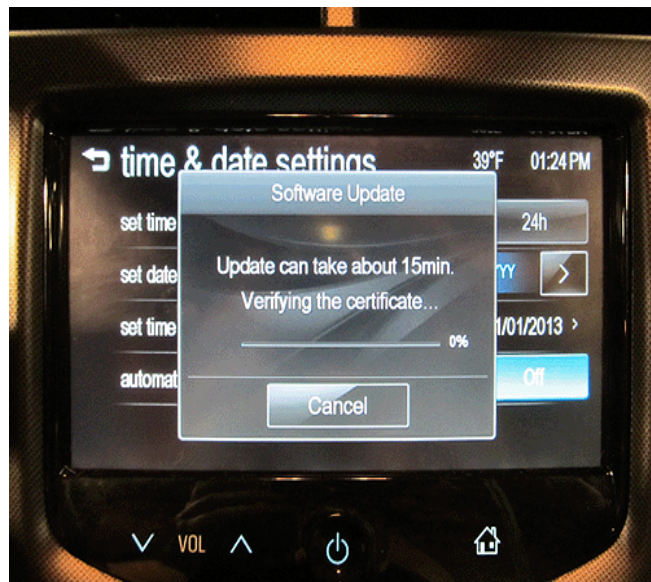
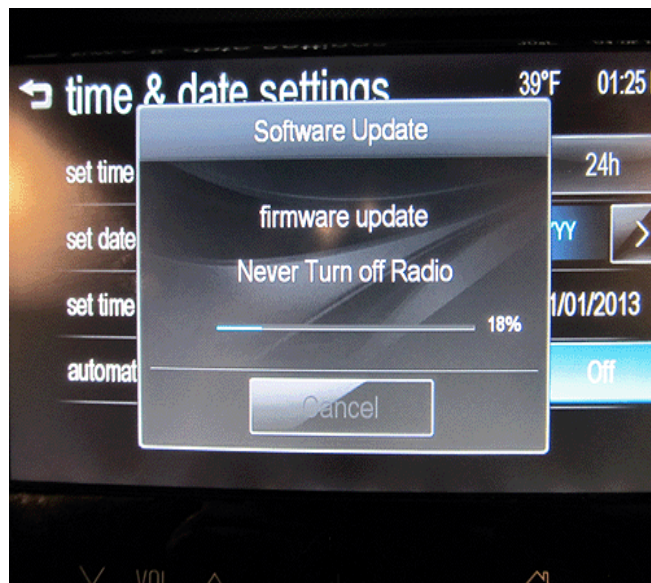
**Note:** If you still see the message "The following update file is Invalid SMD file," the date has not been changed correctly on the radio.

15. When the update info screen comes on, select UPDATE.
