Service Bulletin

Bulletin No.: PI0914B

Subject: MyLink Radio – Software Enhancement Update to Add BringGo and TuneIn Radio Applications and Siri Eyes Free – U.S. and Canada Only

Models: 2013 Chevrolet Sonic Built Prior to February 8, 2013
2013 Chevrolet Spark Built Prior to February 18, 2013
2013 Chevrolet Trax Built Prior to March 11, 2013
Equipped with Uplevel Radio (RPO UF7)

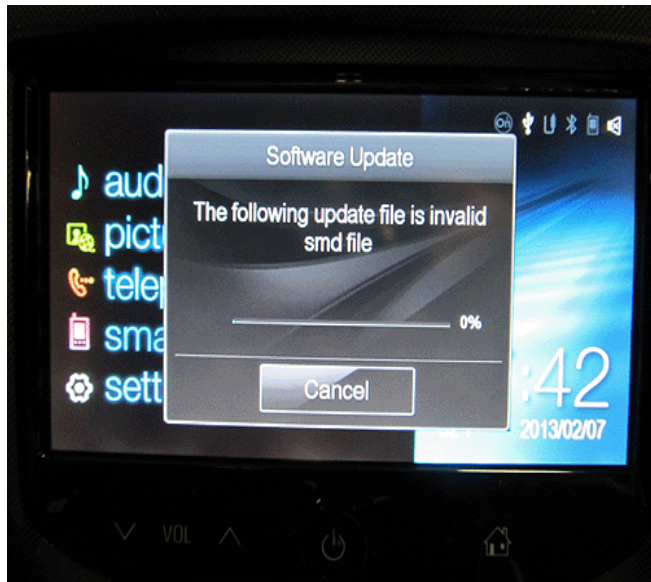
3286662

8. If you see the message as shown above "The following update file is Invalid SMD file," continue to the next step. Otherwise, skip to Step 14.
